# Insulation Fire in Brussels

Lessons learned from incident in uniquely constructed high rise

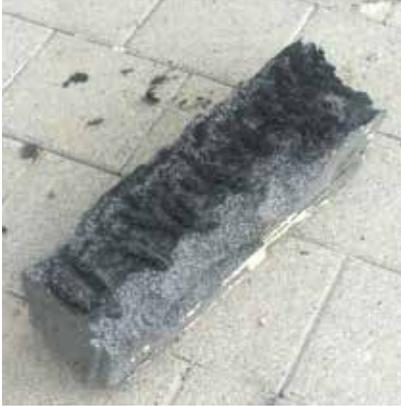
**The partially burned EPS insulation. The upper part was smoldering and had blackened.**  
*Photo by Pieter Maes*

stains along with partially melted and discolored insulation showed that the fire had indeed spread.

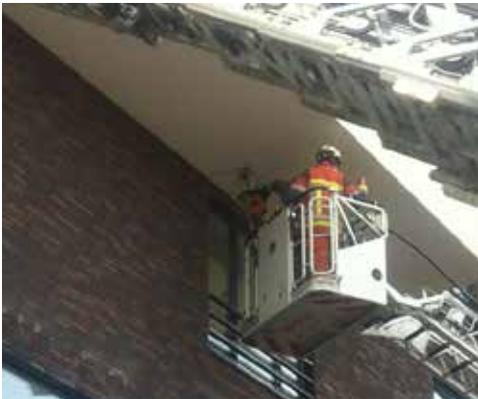
**The crew moves five meters and makes a new cut.**  
*Photo by Pieter Maes*

The crew was asked to move five meters farther and make another cut in the insulation. Again, the fire had spread beyond this point.

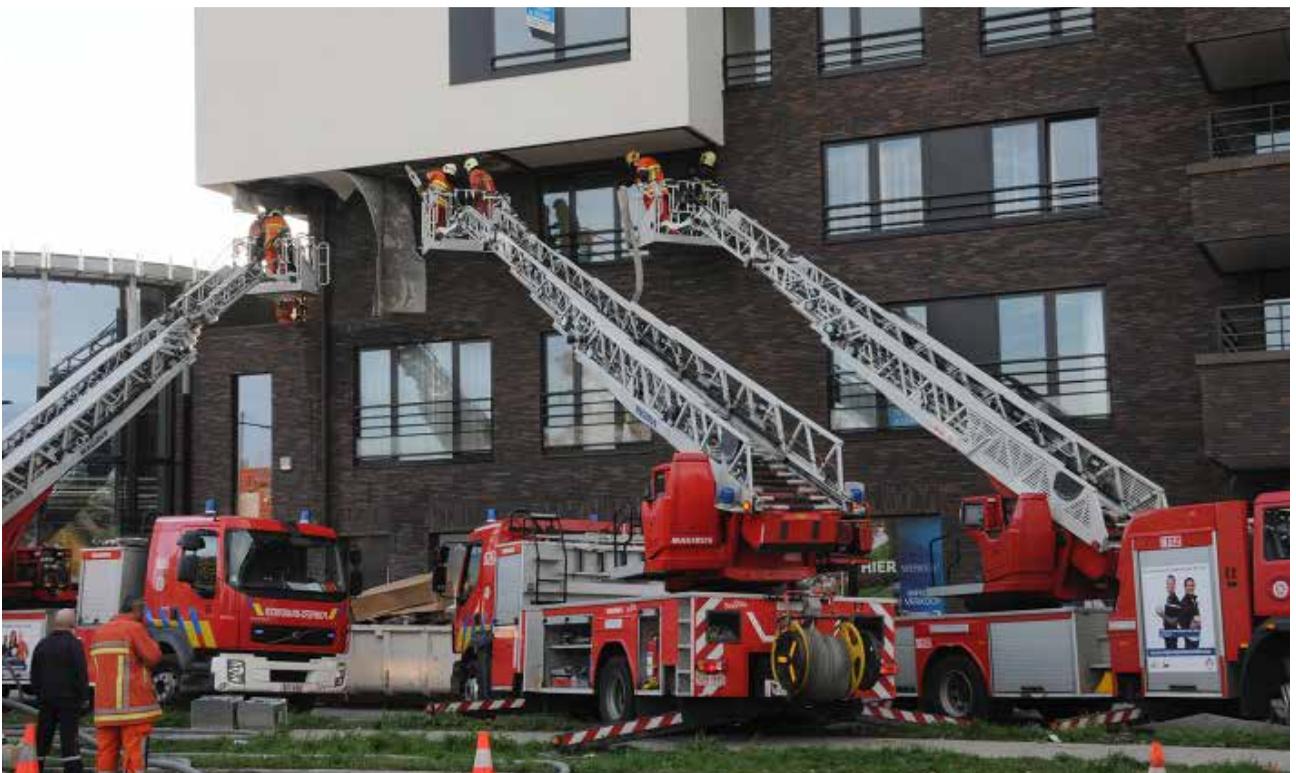
**Three ladder trucks working to clear the plaster and the EPS insulation.** *Photo by Robert Dekock*

The strategy was to remove the fuel and extinguish/remove the burning bits. Like in forest firefighting, “firebreaks” were created in the plastered sections by making saw cuts and removing the insulation.

Crews checked whether the edges of the cuts consisted of unburnt material. If they did, then the firefighters would be certain that the fire has been cut off. Aside from outlining the fire in the plaster wall section, the brick section was taken care of by drilling holes in several places and inserting a piercing nozzle.

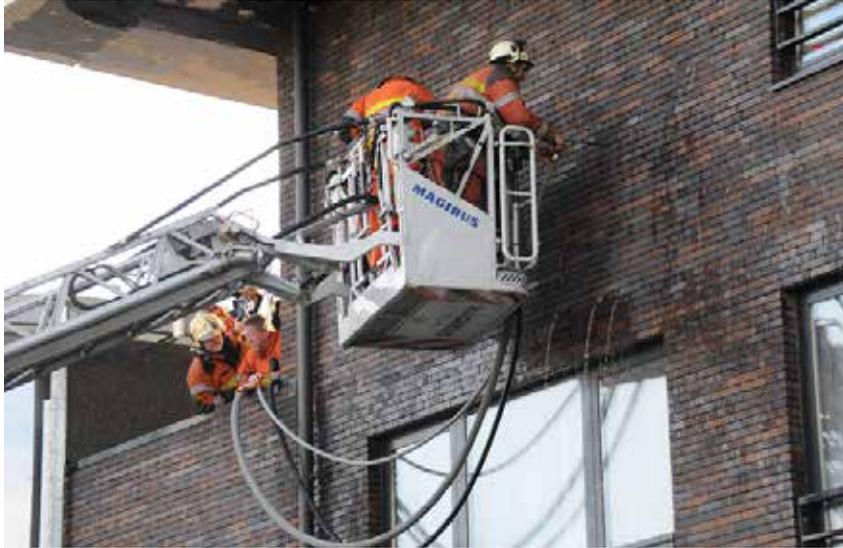
Piercing nozzles in use. First a hole was made using a power drill. Next a piercing nozzle was used to flow water inside. The water was running downward over/through the insulation.

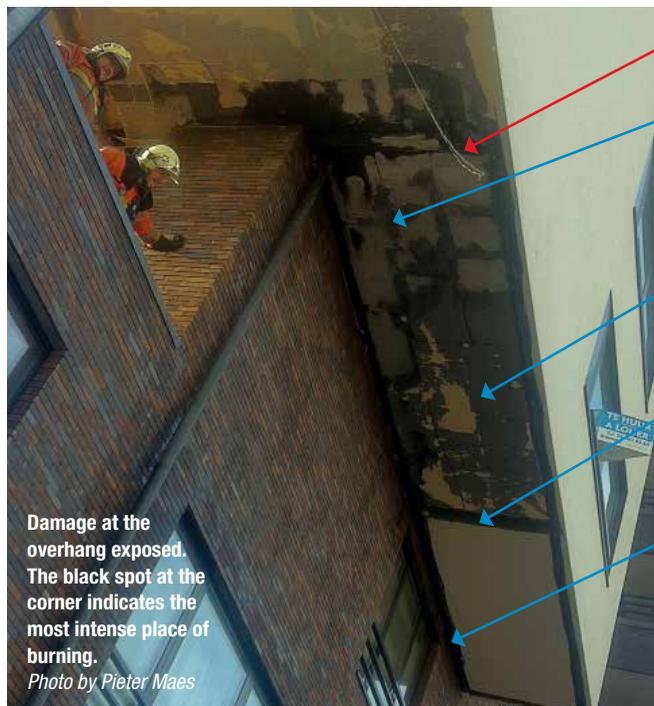
Damage at the overhang exposed. The black spot at the corner indicates the most intense place of burning.

The fire was progressing slowly but steadily, and it was unclear how far it had spread. The fire had started in a single vertical wall section and was now in the horizontal pane under the overhang. Moreover, the fire had passed the corner inside the brick wall, creating a smoldering fire in a second vertical pane. A very clear distinction had to be made between a smoldering fire in a vertical pane and in a horizontal pane. After all, the fire would spread much quicker upward than sideways. At this point, crews were worried that the fire would reach the edge of the overhang and start travelling upward again, which could lead to grave consequences.

The final damage was relatively limited. The brick wall had been punctured in about a dozen places. In the plastered sections, there was substantially more damage. The bottom side of the overhang needed to be replaced almost entirely. The last photo indicates the fire’s reach. Crews halted the fire at about 20 to 30 cm from the edge of the overhang. ■
