Construction fires: insulation fire in Evere

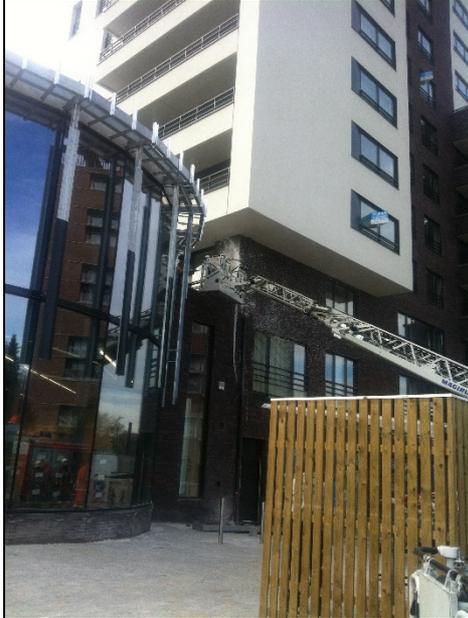
Figure 3 The situation upon arrival of Helihaven fire station. Schaarbeek crews are working the fire with a high pressure line. (Photo: Pieter Maes)

Upon arrival, the crews of Schaarbeek station are greeted by roofers. These were busy placing roofing on the section of flat roof in between the two buildings. The flame of the blow torch that they were using, was accidentally directed up the brick wall. This caused the PUR insulation in between the brick and the inner wall, to burn. However the outer brick layer is making it very hard for fresh air to reach the fire. This in turn, causes the fire to smolder.

The fire service has set up a ladder truck and deployed a high pressure booster line. Water was being flowed both onto the wall and into the cavity in order to extinguish the fire.

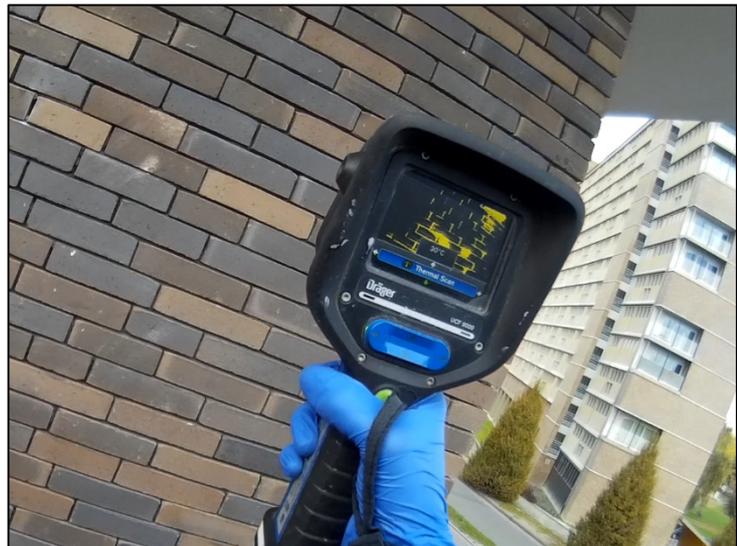
Figure 4 The wall is looking fine. However, the TIC is clearly showing traces of heat buildup. The mortar joints and some of the bricks are highlighting. (Photo: Karel Lambert)

After about 30 seconds, the joints light up again on the TIC followed by an entire section of bricks located in the middle of the wall. The bricks are taking a lot longer to warm up however (in between four to nine minutes). This leads the officers to conclude that the fire is still smoldering. They will have to wait for the piercing nozzles to fight the fire in the insulation layer.

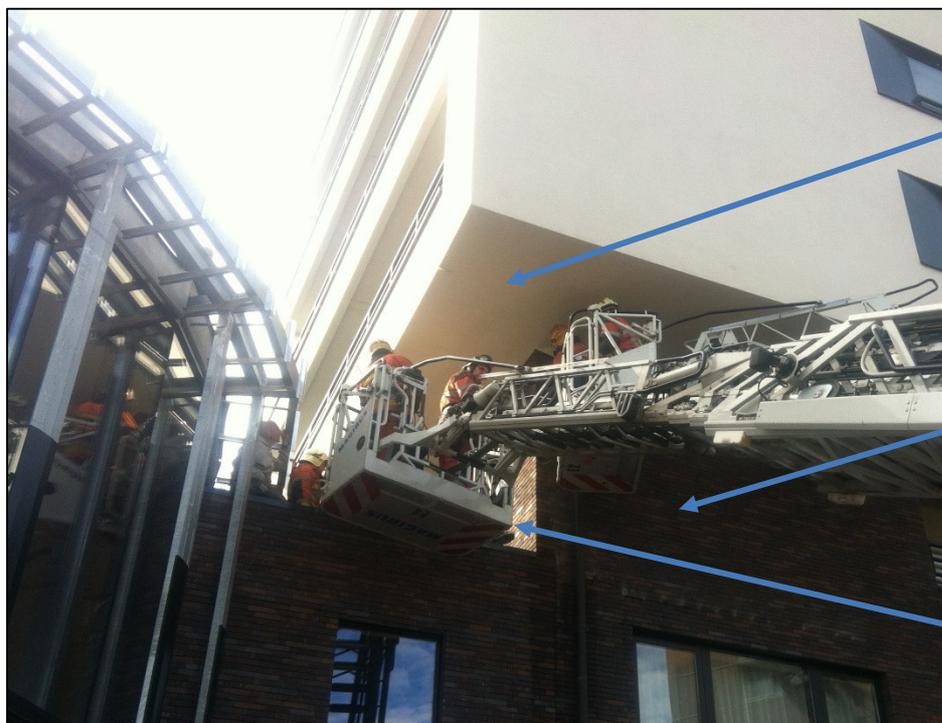
Cantilever section

Possible fire extension

Original seat of fire

Figure 5 Left on the image, the ladder crew of Schaarbeek station is working. Several firefighters are on the flat roof. That's where the fire started in the brick wall between the roof and the cantilever section. The section of wall indicated with the bottom blue arrow is about 2 meters wide. There's a possibility that the fire will pass the corner and create possible fire extension across the entire brick wall. (Photo: Pieter Maes)

The fire is progressing slowly but steadily. It's unclear how far the fire has spread. The fire started in a single vertical wall section (bottom arrow of Figure 5) and is now in the horizontal pane at the bottom end of the overhang. Aside from that, the fire has probably passed the building corner inside the brick wall. So there's also a smoldering fire in a second vertical pane indicated as "possible fire extension" on Figure 5. There's a very clear distinction being made here between a smoldering fire in a vertical pane and a smoldering fire in a horizontal pane. After all, the fire will spread much quicker upwards than it will sideways in the vertical pane of the overhang.

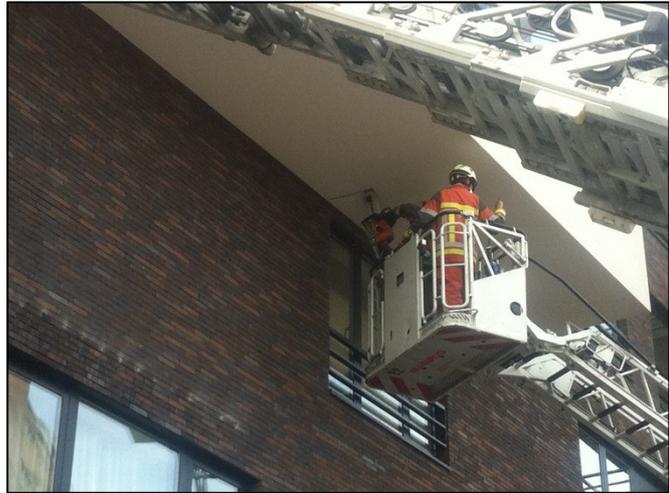
A crew is then asked to move about five meters further down the wall underneath the overhang and make another cut in the insulation. Again they need to check whether the fire has spread that far (see Figure 7). This takes some time to accomplish, but again the crew reports that the fire has spread beyond this point. This means that the fire has already travelled over 6 meters horizontally.

Figure 7 The crew moves five meters down the wall and makes a new cut with the technical rescue chainsaw. (Photo: Pieter Maes)

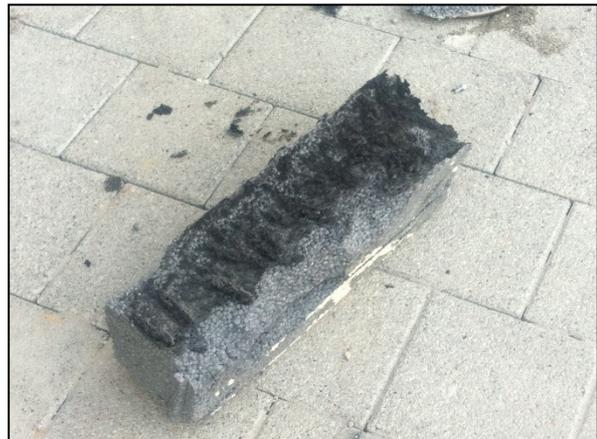
Shortly after, crews report that the fire has spread in the section around the rain pipe. The rain pipe is situated about half a meter from the side corner. A section of 50 cm by 50 cm has been cleared and the fire has already spread beyond this section. Soot stains along with partially melted and discolored insulation are proof of this (see Figure 8).

Figure 8 Photograph of the partially burned EPS insulation. The upper part was smoldering and has blackened. The rest of the piece has retained its original grey color. (Photo: Pieter Maes)

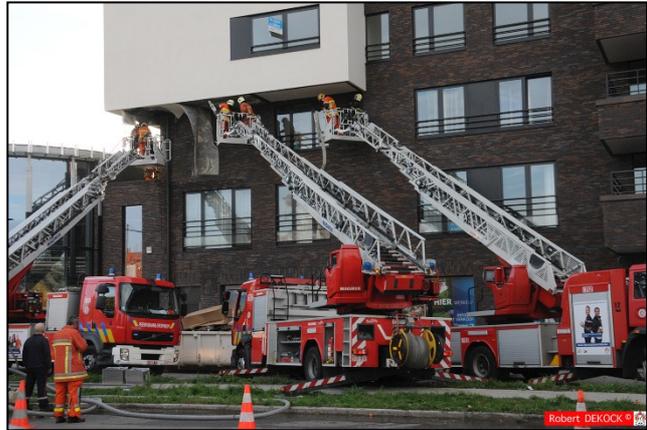
Figure 9 Three ladder trucks are working to clear the plaster and the EPS insulation. (Photo: Robert Dekock)

The rest of the overhang has been more heavily damaged. The exterior plaster has been removed over a large surface area. Figure 9 shows a band of plaster hanging down. After removal of the plaster there was often a clean and unburnt piece of EPS visible. That did not mean however, that there wasn't a smoldering fire inside the material or between the insulation and the concrete. Figure 11 shows us several sections in different colors. Far right there's the unburnt plaster. This section is outlined by trench cuts. In the section next to that, there's unburnt EPS. This is the dark grey section. In the area around the corner, there's a light grey section visible. Here the EPS insulation has been removed. The light grey color is that of exposed concrete.

The same as in forest fire fighting, "firebreaks" are made in the plastered sections. When the fire has been outlined, it can't spread any further. This is done by making saw cuts. The technical rescue chainsaws of FD Brussels are critical for this task. After the first cut is made, a second one is made parallel to the first one at about 15 cm. Next the insulation between the two cuts is removed.

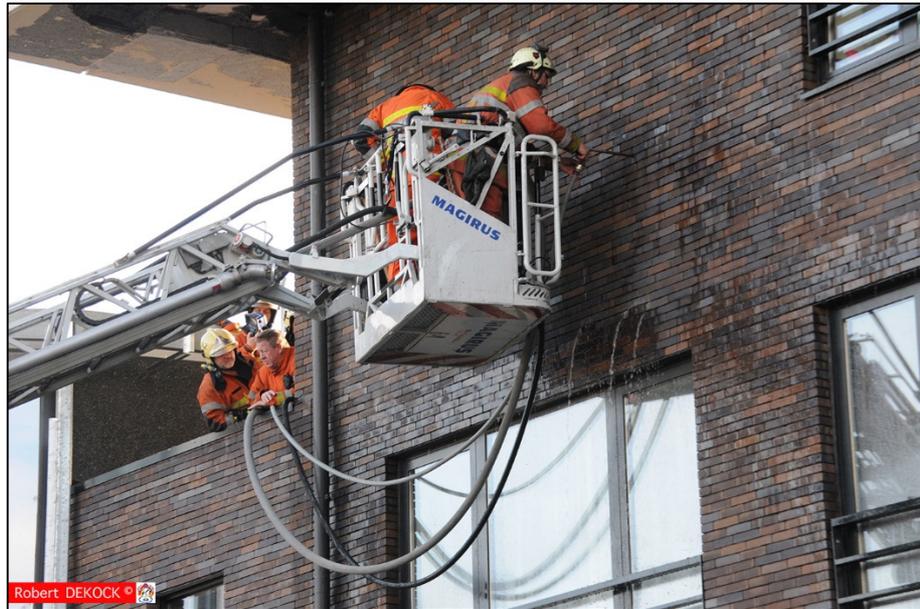
Figure 10 Piercing nozzles in use. First a hole is made in the brick wall using a Hilti power drill. Next a piercing nozzle is used to flow water inside. The water is running downwards over/through the insulation. The photographs show the water running back out through the weep holes. (Photo: Robert Dekock)

Aside from outlining the fire in the plaster wall section, the brick section is taken care off by drilling holes in several places and putting in a piercing nozzle (see Figure 10).

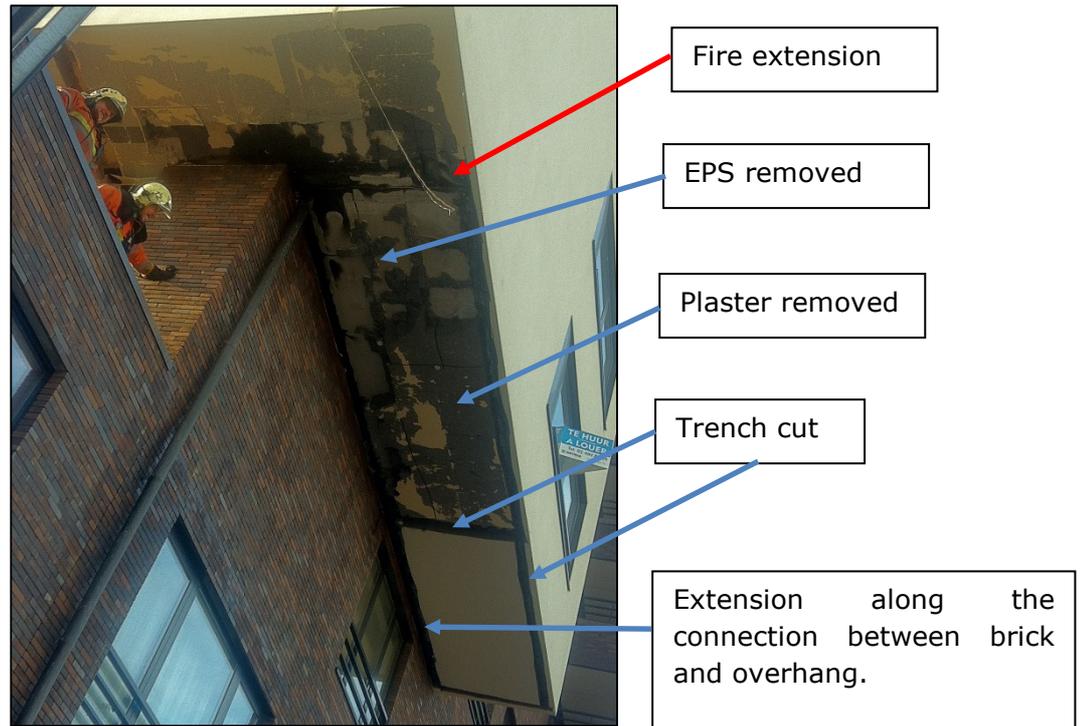
In the plastered sections there's substantially more damage. The bottom side of the overhang needs to be replaced almost entirely. The fire has travelled primarily along the connection of the vertical brick wall and the horizontal EPS insulation, so a section of only 20-25 cm needed to be cleared in the area furthest from the original seat of fire (see Figure 11).

Figure 11 Damage at the overhang exposed. The black spot at the corner indicates the most intense place of burning. The red arrow shows that the fire had spread up to 20-30 cm of the edge. The blue arrows indicate different areas where fire crews have removed building materials. (Photo: Pieter Maes)

Figure 11 also shows how far the smoldering fire had gotten in the insulation. The fire has left soot stains on the concrete. The red arrow indicates how far the fire got. The fire service succeeded in halting the fire at about 20 to 30 cm from the edge of the overhang.

One important detail is that all of the cuts at the bottom of the overhang are made a few centimeters away from the edge of the overhang. By doing this, the vertical walls have remained undamaged. This will facilitate the repairs.

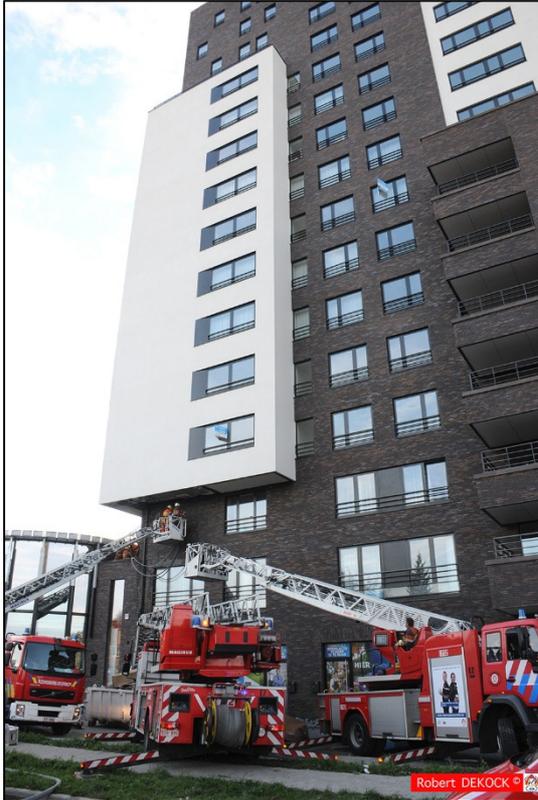
Figure 12 Overview of the facade. (Photo: Robert Dekock)

Figure 12 is a picture of the building facade. This picture clearly shows what would have happened if the fire had reached the edge of the overhang.
