# Ukkel

## 1 Introduction

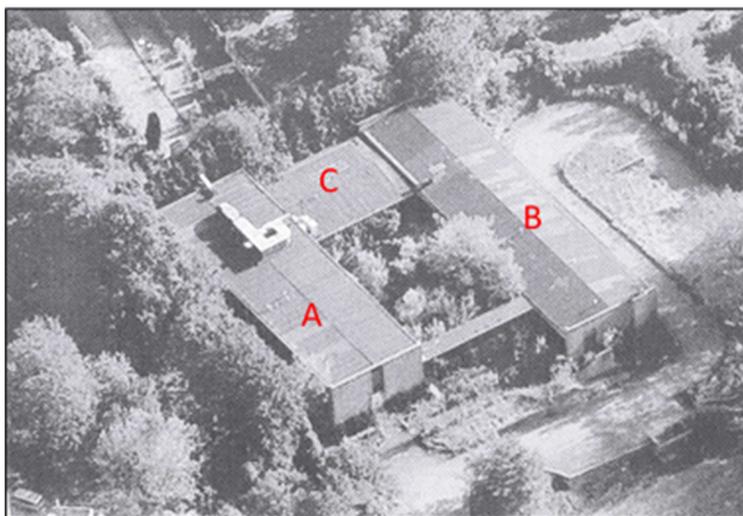
The building is part of large complex made up of three abandoned buildings which are built in the shape of a U. Figure 3 clearly shows these three buildings. Aside from the buildings themselves, Figure 3 also clearly shows the slope on which the complex is built. The far left building is designated as building A and was fully involved upon arrival of the fire service. The building that's located parallel to building A is designated building B. This building was slightly larger than A measuring about 45 m. The width was the same at 14 m. At the time of arrival, this building had not yet been affected by the fire. There was no smoke in building B. The area between both buildings used to be a yard or patio. At the back end of the yard, there was another building. This is building C which measured 16 x 13 m. At the side where the road ran next to the yard, a covered walkway further enclosed the yard. This walkway allowed people to travel between buildings A and

**Figure 3** The buildings before the fire. From left to right: A, C and B. The overgrown yard is clearly visible. (Photo: unknown)

All of the buildings had been abandoned for several years. The yard between buildings A and B was completely overgrown. The original plants had grown into trees. Figure 3 clearly shows the trees and bushes. The yard has become as small forest with trees and plants reaching up to 15 m.

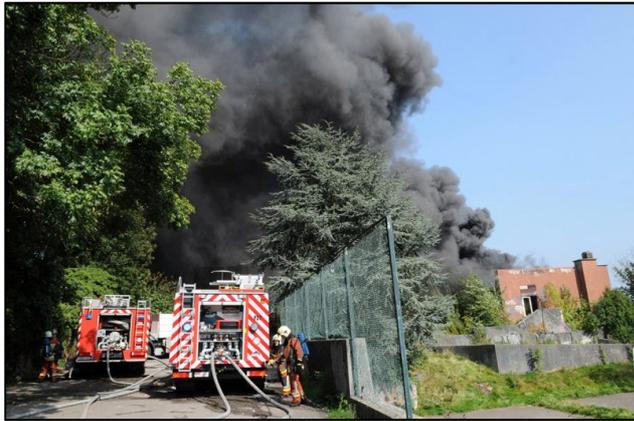
**Figure 4** Picture taken at 15u32. Building A is hidden from view behind the smoke. The captain of Helihaven has just exited building B after the smoke explosion occurred. When the fire crews arrived 40 minutes earlier, building B seemed to be completely unaffected. (Photo: Robert Decock)

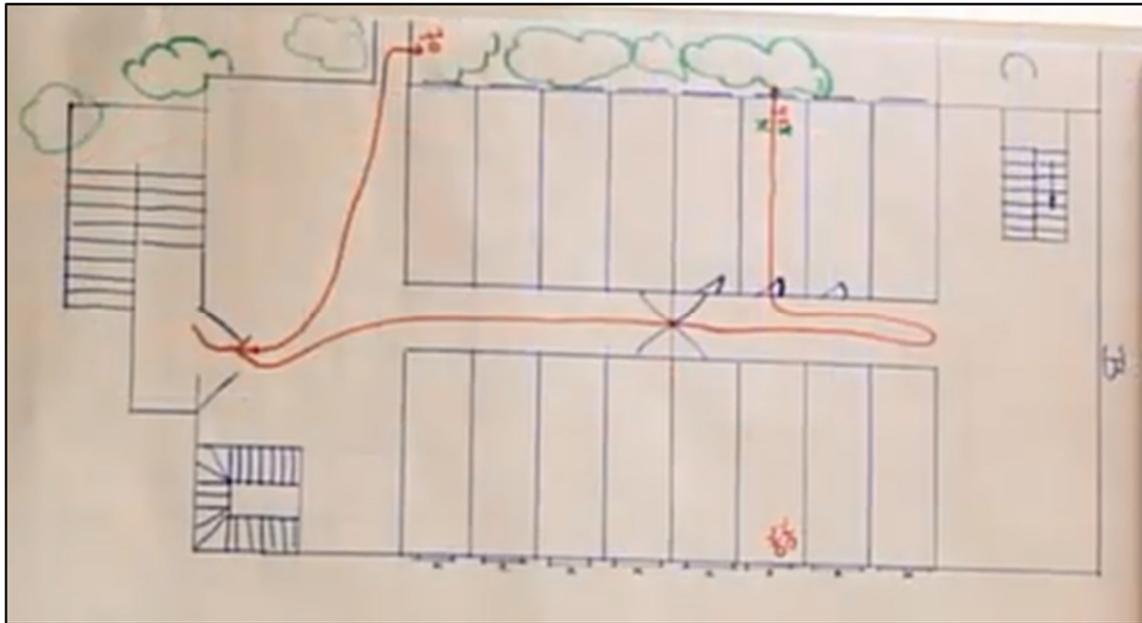
**Figure 5** Layout of building B. The hose lines are drawn in red. The Ø 70 mm on the left and the Ø 45 mm on the right. The two blue, vertical lines next to the Ø 70 mm are the beginning of the covered walkway. In the middle of the central corridor there's a double door. (Drawing: Bert Vandeneynde, copied from [3])

Since the probationary battalion chief was the only woman on the fire ground, everyone immediately knew who was in trouble. The crew manning the Ø 70 mm hose line, stopped flowing water and started looking for her. However, they had initially laid out their hose line in perfect visibility. Now, they have to work their way through heavy smoke. Initially they try to find the central hallway. While doing that, they end up in the staircase that was located to the right of the entrance on Figure 5.

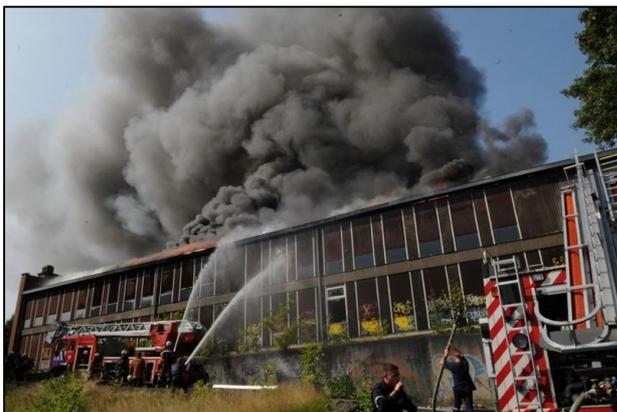
**Figure 6** The side view of building B. All windows have been boarded up except for one. The probationary officer escapes the building through this opening. (Photo: Robert Decock)

The probationary officer realizes she is running out of time and staying hunkered down is not an option. She sees a sign indicating an exit and crawls towards the staircase. The staircase has been barricaded, but she manages to drop herself down into it. On the floor below, she sees light. She moves towards the light and finds a single window that hasn't been boarded up. Through this window, she finds a way out to safety and so survives the tragedy.

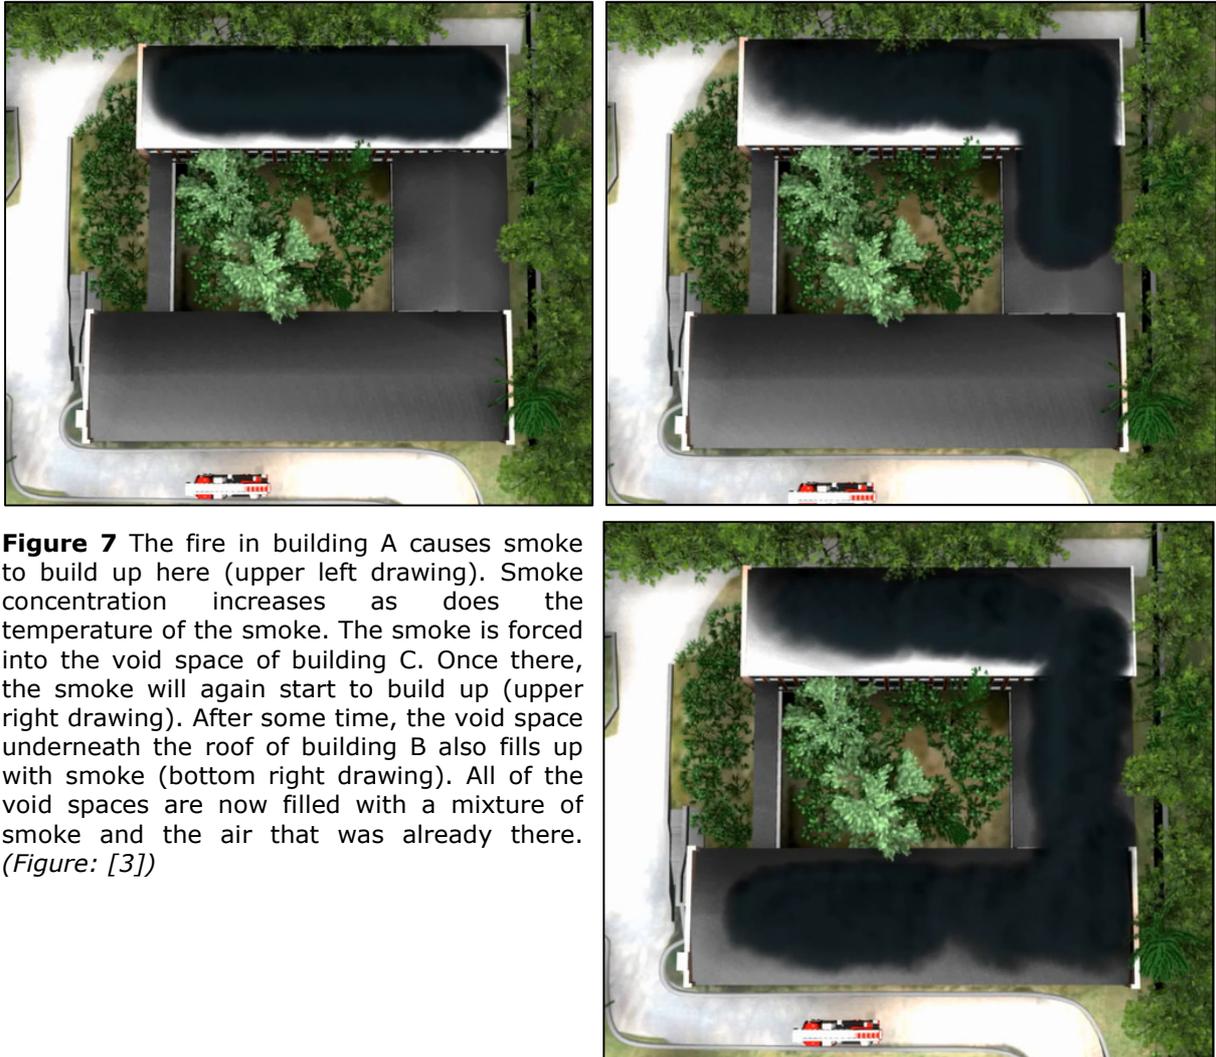
At some point in time, an ignition occurred in building A. This ignition caused a smoke explosion. A smoke explosion is a fire gas ignition of an almost ideal mixture of smoke and air. Ignition of such a mixture causes significant pressure waves.

**Figure 7** The fire in building A causes smoke to build up here (upper left drawing). Smoke concentration increases as does the temperature of the smoke. The smoke is forced into the void space of building C. Once there, the smoke will again start to build up (upper right drawing). After some time, the void space underneath the roof of building B also fills up with smoke (bottom right drawing). All of the void spaces are now filled with a mixture of smoke and the air that was already there. (Figure: [3])

The operator testifies that next, the roof was lifted up slightly and the side walls of building B collapsed. The escape route of the team manning the  $\varnothing$  45 mm line was now cut off. The force needed to lift the roof, suggests a smoke explosion happened. First a pressure wave moves through the mixture of air and fire gas towards building B. Shortly after, the wave is followed by flames. This means that downstream of the ignition, two events occur. First the pressure wave, which is powerful enough to cause the (partial) collapse of the ceiling. And quickly after that, the flames which in turn causes everything to catch fire. Temperature inside will then increase rapidly. The difference between conditions before the occurrence of the flame front and after, should be clearly noticeable.

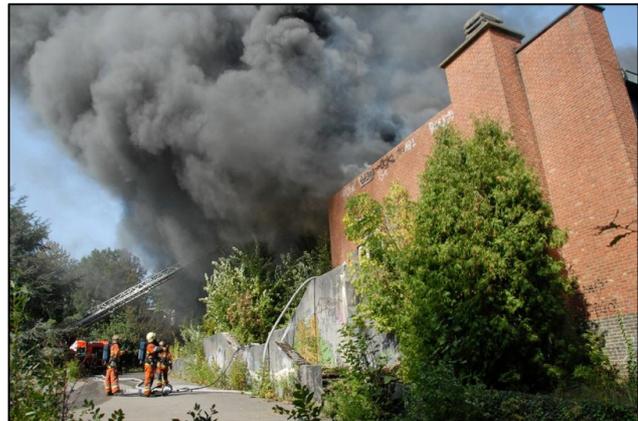
**Figure 8** View of the front of the building. Notice the staircase that provides access to the upper floor level. Also take note of the rectangular shape of the brick wall. Behind this wall, there's a pitched roof hidden from view. (Photo: Robert Decock)

The difference in height also made that people at the bottom along the longer wall (with boarded windows), did not have a good view on the situation. From down there, it wasn't clear that the buildings had a pitched roof (see Figure 6). The rectangular walls at the front reinforced this impression.

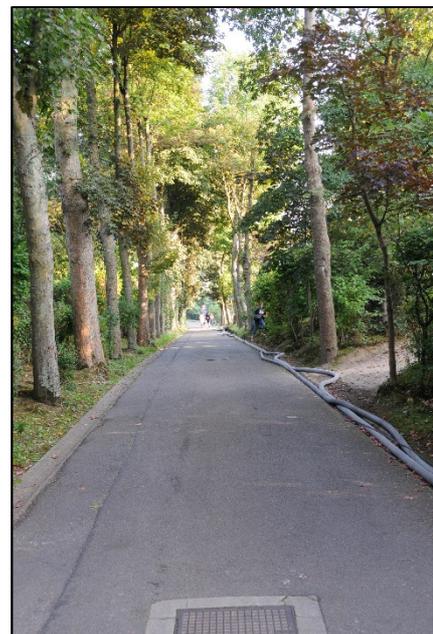
It took about 15 minutes before an adequate water supply was available. This is a rather large time frame which is unusual for the Brussels fire service. The large distance between the location of the different vehicles and the hydrants, led to very long lengths of hose lines. Next to that, the height difference caused extra pressure losses which required some lines to be doubled.

**Figure 9** The water supply line going from the hydrant to the engine was exceptionally long. (Photo: Robert Decock)

After the incident, the length of ladder hose reel was increased. Also the number of hoses in the engine was increased. The recent change into the use of coiled packs, cassettes and hoses in zig zag, allows for a higher total of hose line to be put in each vehicle. On top of this, these type of hose line configurations are more suited for quickly stretching out long lines as opposed to classic rolled up hose lines.

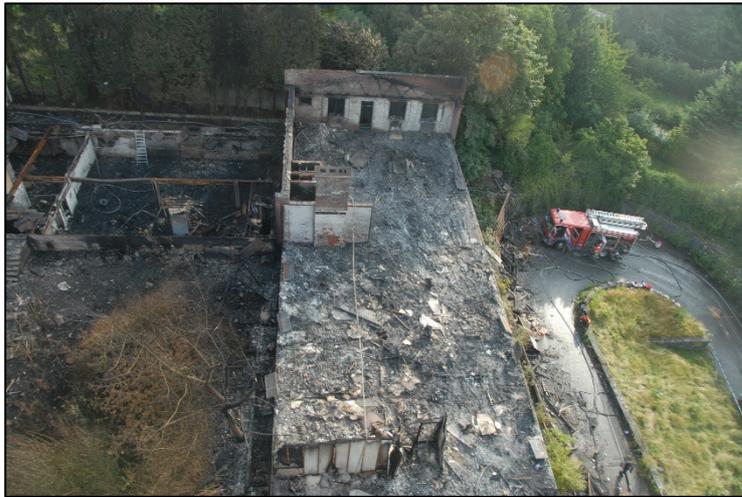
**Figure 10** Top down view on to the burnt down buildings B and C. In both buildings, the concrete and steel structure is still intact. The wooden structure above it has burned down completely. On the rectangular wall of building B there's still a charred imprint visible of the trusses that supported the roof. This gives an idea of the volume between the roof and the false ceiling. This picture also shows the trees behind the building, as well as the fence. Because of these, a 360° size up during the incident was impossible.

In Ukkel, each building had the bottom floor made out of concrete and steel. On top of this, a light weight wooden construction was placed. Such type of construction is very common in the US. They are characterized by a very low fire resistance. When exposed to any decent fire, they collapse rather quickly. On top of this, a pressure wave will do a lot more damage. After all, such type of construction weighs very little.

An additional issue was that the roof of building B was barely fastened to the supporting walls at all. The walls carrying the roof, stayed in place by the weight of it. The roof was therefore very important for maintaining structural stability.

The original blueprints of the building indicated a prefabricated roof structure made out of metal was to be placed. In reality however, a prefab wooden structure was used. This is a very important change to the building. The metal trusses would have been stronger and heavier than the wooden structure. Aside from that, it needs saying that the wooden trusses added to the fire load. This would not have been the case with a metal structure.

The smoke explosion produced a pressure wave. This pressure wave lifted the roof and pushed the wall outwards. When the overpressure subsides a second later, the roof falls back down. And now it is no longer supported by a wall which in turn causes part of the structure to collapse. This collapse is what killed lieutenant Batselier. So in that regard, the type of construction is an important factor in the outcome of the incident.

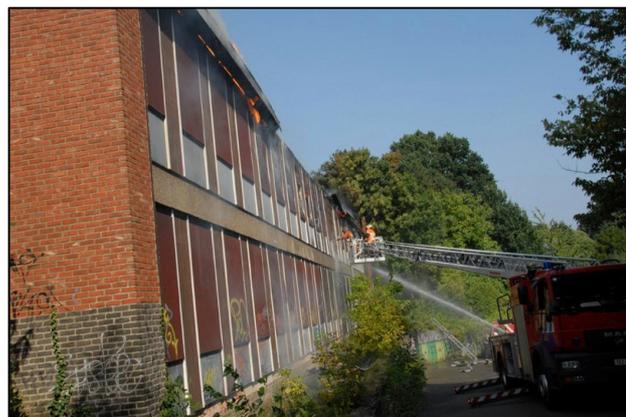
Another aspect that's specific for this fire ground, is that the fire was raging in an abandoned building. All of the windows in the outer wall were boarded shut (except

**Figure 11** View of the side wall of building B. The wooden boards sealing off the windows are clearly visible. At the far end, crews are doing a rescue attempt from the ladder basket. *(Photo: Robert Decock)*

for a single window on the bottom floor). The plywood boards used on the windows are also used to build molds for concrete form work. This means that the boards are very sturdy.

As soon as crews saw one of the boards moving, the location of the crew in trouble was known. Firefighters tried to remove the boards. This had to be done from the basket of the ladder truck. Crews on the outside had to overcome an additional disadvantage: the ladder was set up and placed ideally for extinguishment, but not for reaching and forcing that specific window panel. Next, it turned out that the boards weren't nailed but screwed into the wall. On all the windows of the top floor, even double boards had been used with mineral wool insulation stuffed in between. From the basket of the ladder truck, firefighters desperately tried to remove the boards (see Figure 11). All help would eventually come too late. It quickly became clear for the people manning the ladder, that their rescue efforts had been unsuccessful.

When the windows are boarded shut, this assumption is no longer correct. In that case, we only have a single escape route left. This signifies a decreased level of safety. A procedure "abandoned buildings" will have a crew specifically tasked with opening up windows. As soon as it's clear that the fire service is dealing with an abandoned building, that additional crew is deployed. Often this crew has some extra technical equipment for this task. If needed, an extra ladder truck is dispatched. Several windows will then be opened back up, and their location forwarded to the interior crews. In the case of Ukkel, this specific action could have made a big difference. The smoke explosion happened about 40 minutes after the arrival of the first engine. In hindsight, there probably was enough time to remove a few boards beforehand and provide a way out for corporal Tacquenière.
