Difficult fire in a museum

January 18th, 2021, the Brussels fire department was confronted with a very complex fire in the Palace for Fine Arts, popularly known as “Bozar”, located at Ravensteinstraat 33 in Brussels. What started as a roof fire eventually turned into a long battle against the fire both from the top of the roof as from under the roof. The cold weather does not make the job any easier. Below you will find the story of this fire.

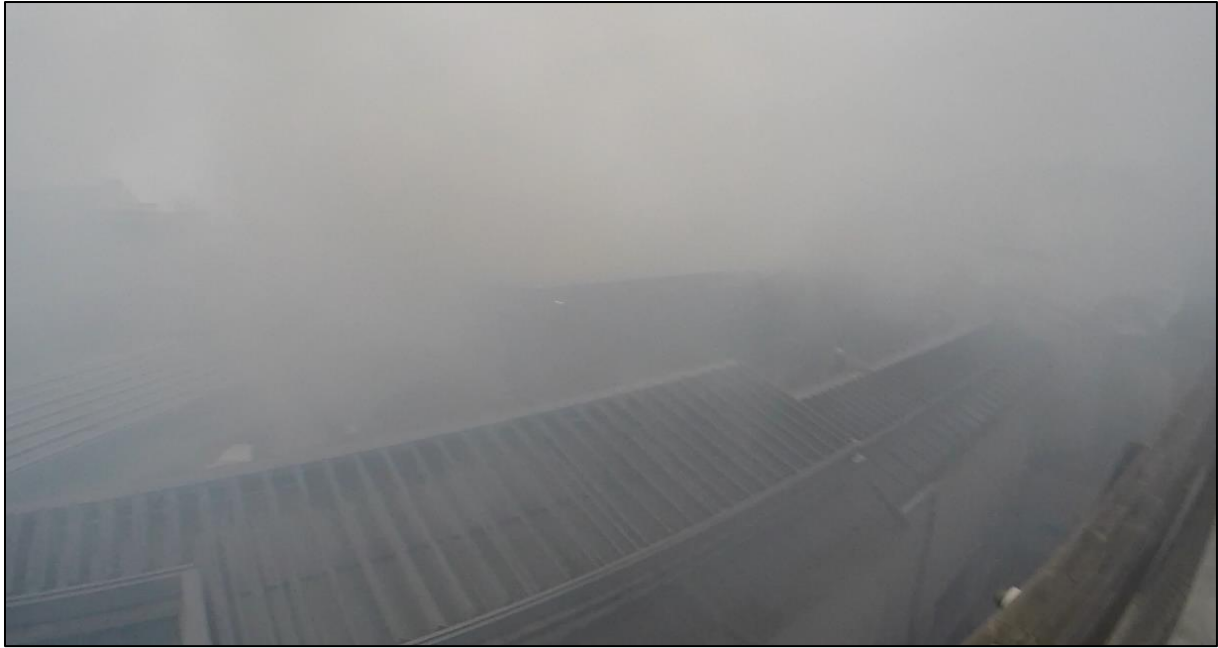
The flames have been put down but the smoke remains consistently hanging above the roof. The limited visibility in combination with the use of A-foam and cold temperatures made the roof dangerously slippery.

Image 4 View at the roof after putting down the flames of the built-up structure. (Picture: Davy Platteau)

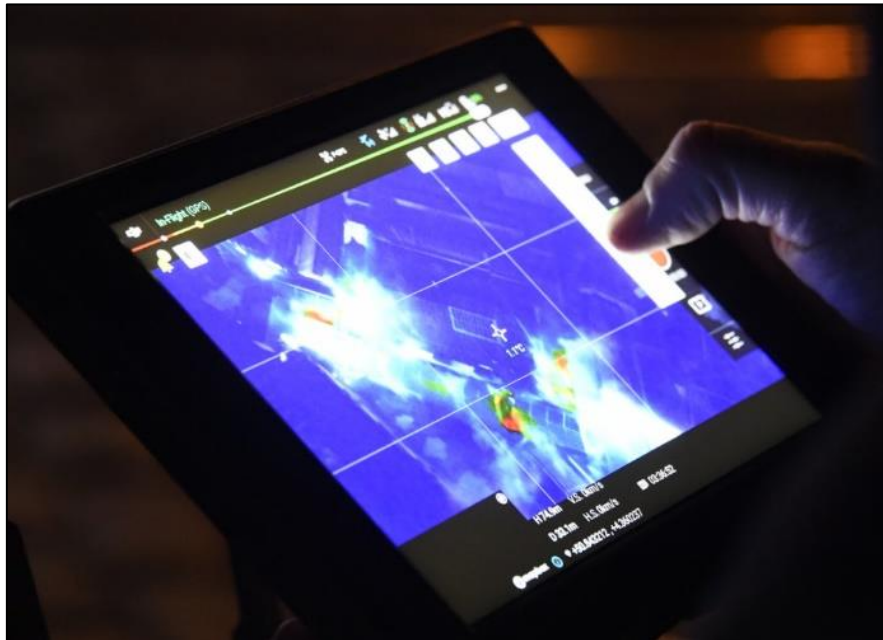
Image 6 The thermal images of the drone are a great support in giving instructions during the intervention. (Picture: Davy Platteau)

The police arrives on the scene with a drone team. The images from the drones appear to be of enormous added value for the further ongoing of the intervention. The thermal imaging camera clearly indicates where the remaining hotspots are. Due to the large amounts of low-hanging smoke (refer to image 4), it is difficult to obtain a good image. The drone can provide decent imaging with its thermal imaging camera.

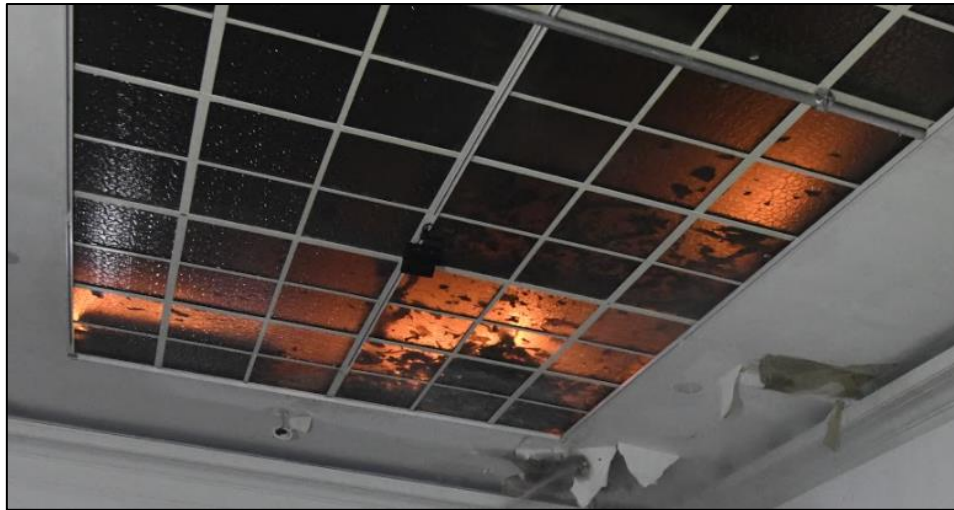
In the meantime, the crew from the engine of Anderlecht is sent inside. Their job is to conduct an interior reconnaissance. After all, the fire has spread about 60 meters under the roof. It is more than likely that there are some fire sources under the roof. They quickly come across the fire that is moving in the false ceiling. On this, they make a stop line with two hoses of 45 mm.

Image 7 View at a glass section of the false ceiling. The fire in it is clearly visible. (Picture: Luc Van Ussel)

With the help of these hoses, they manage to stop the fire in the false ceiling (see image 7).

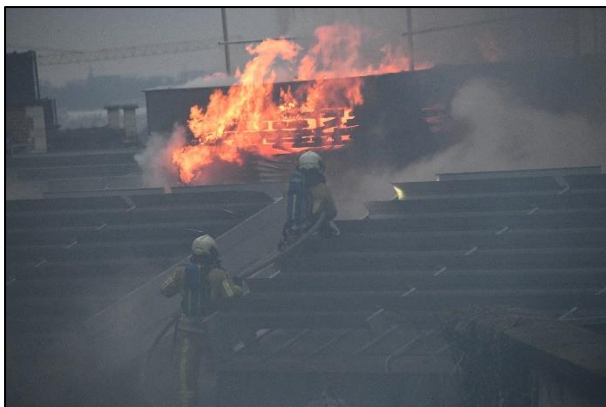
Image 8 Two firefighters at work at one of the burning structures. (Picture: Robert Decock)
