# United States Fire Administration

### High-rise Office Building Fire One Meridian Plaza Philadelphia, Pennsylvania

## United States Fire Administration Fire Investigations Program

This report on the Philadelphia, Pennsylvania, One Meridian Plaza fire documents one of the most significant high-rise fires in United States' history. The fire claimed the lives of three Philadelphia firefighters and gutted eight floors of a 38-story fire-resistive building causing an estimated \$100 million in direct property loss and an equal or greater loss through business interruption. Litigation resulting from the fire amounts to an estimated \$4 billion in civil damage claims. Twenty months after the fire this building, one of Philadelphia's tallest, situated on Penn Square directly across from City Hall, still stood unoccupied and fire-scarred, its structural integrity in question.

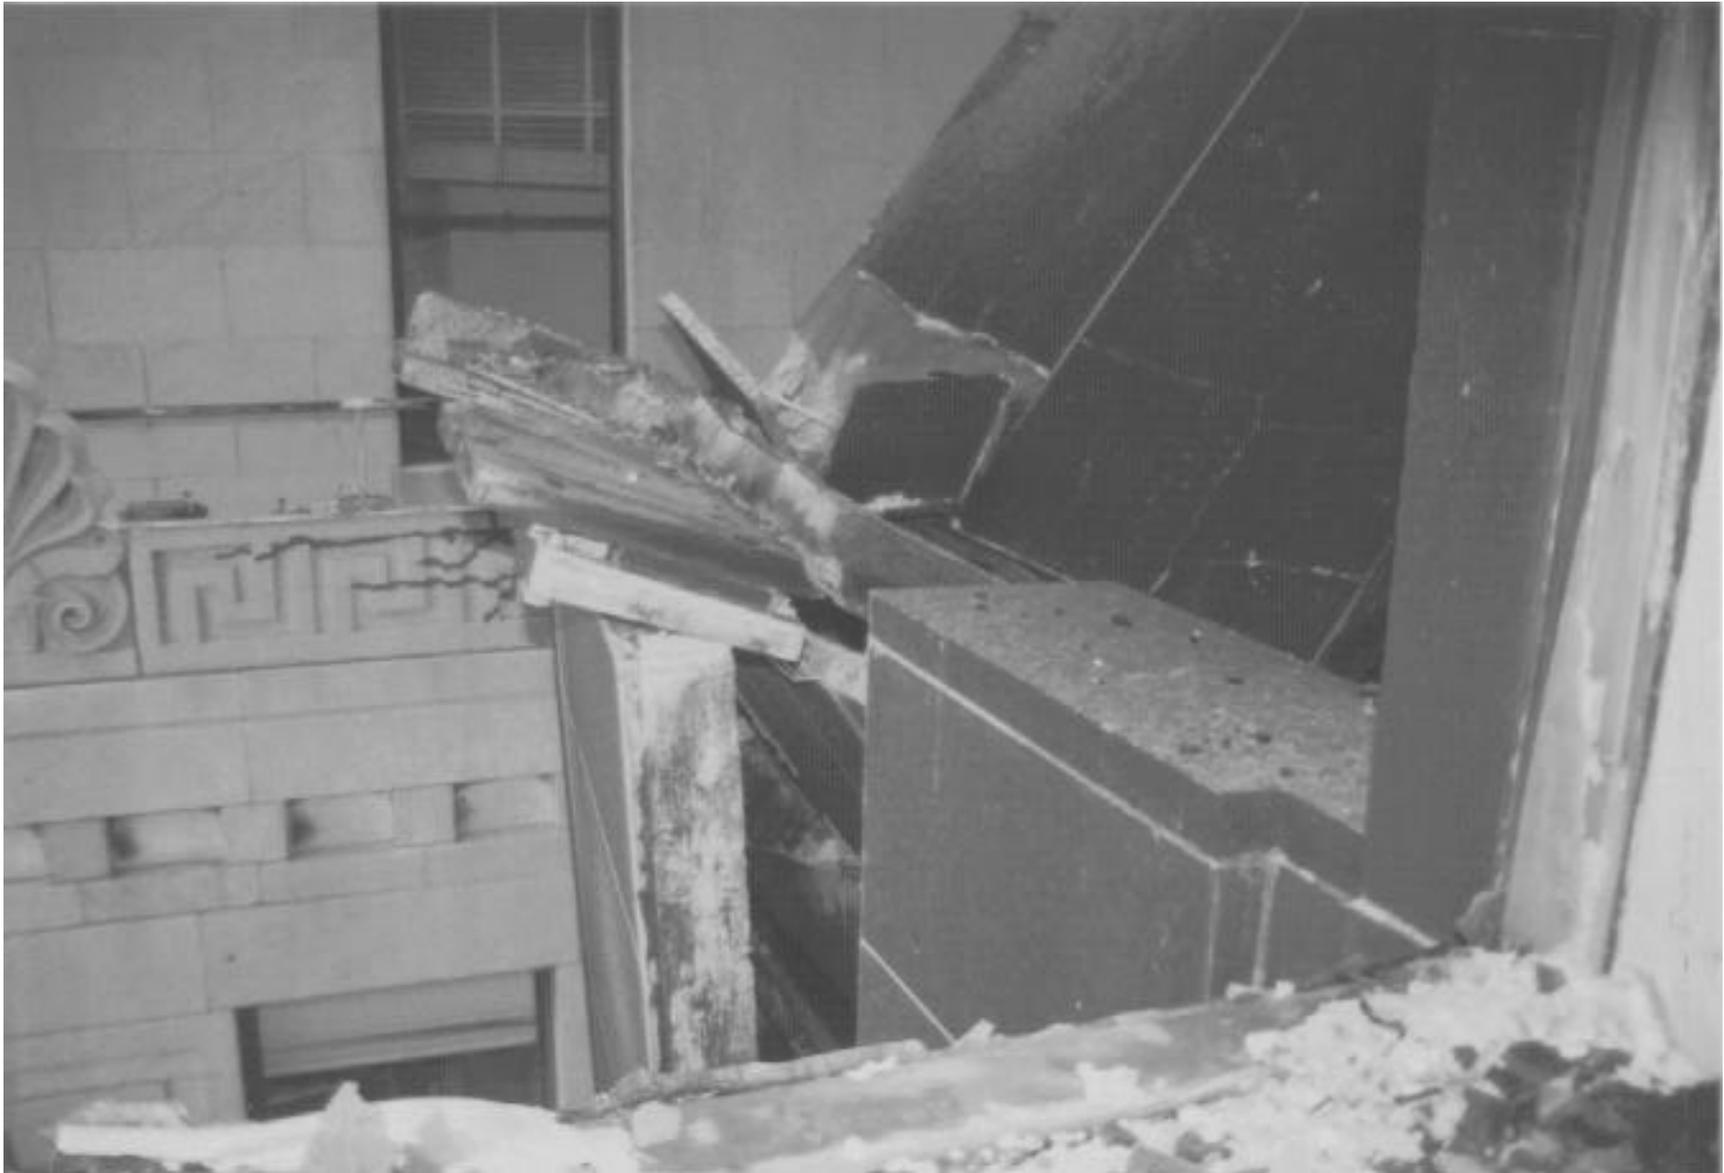
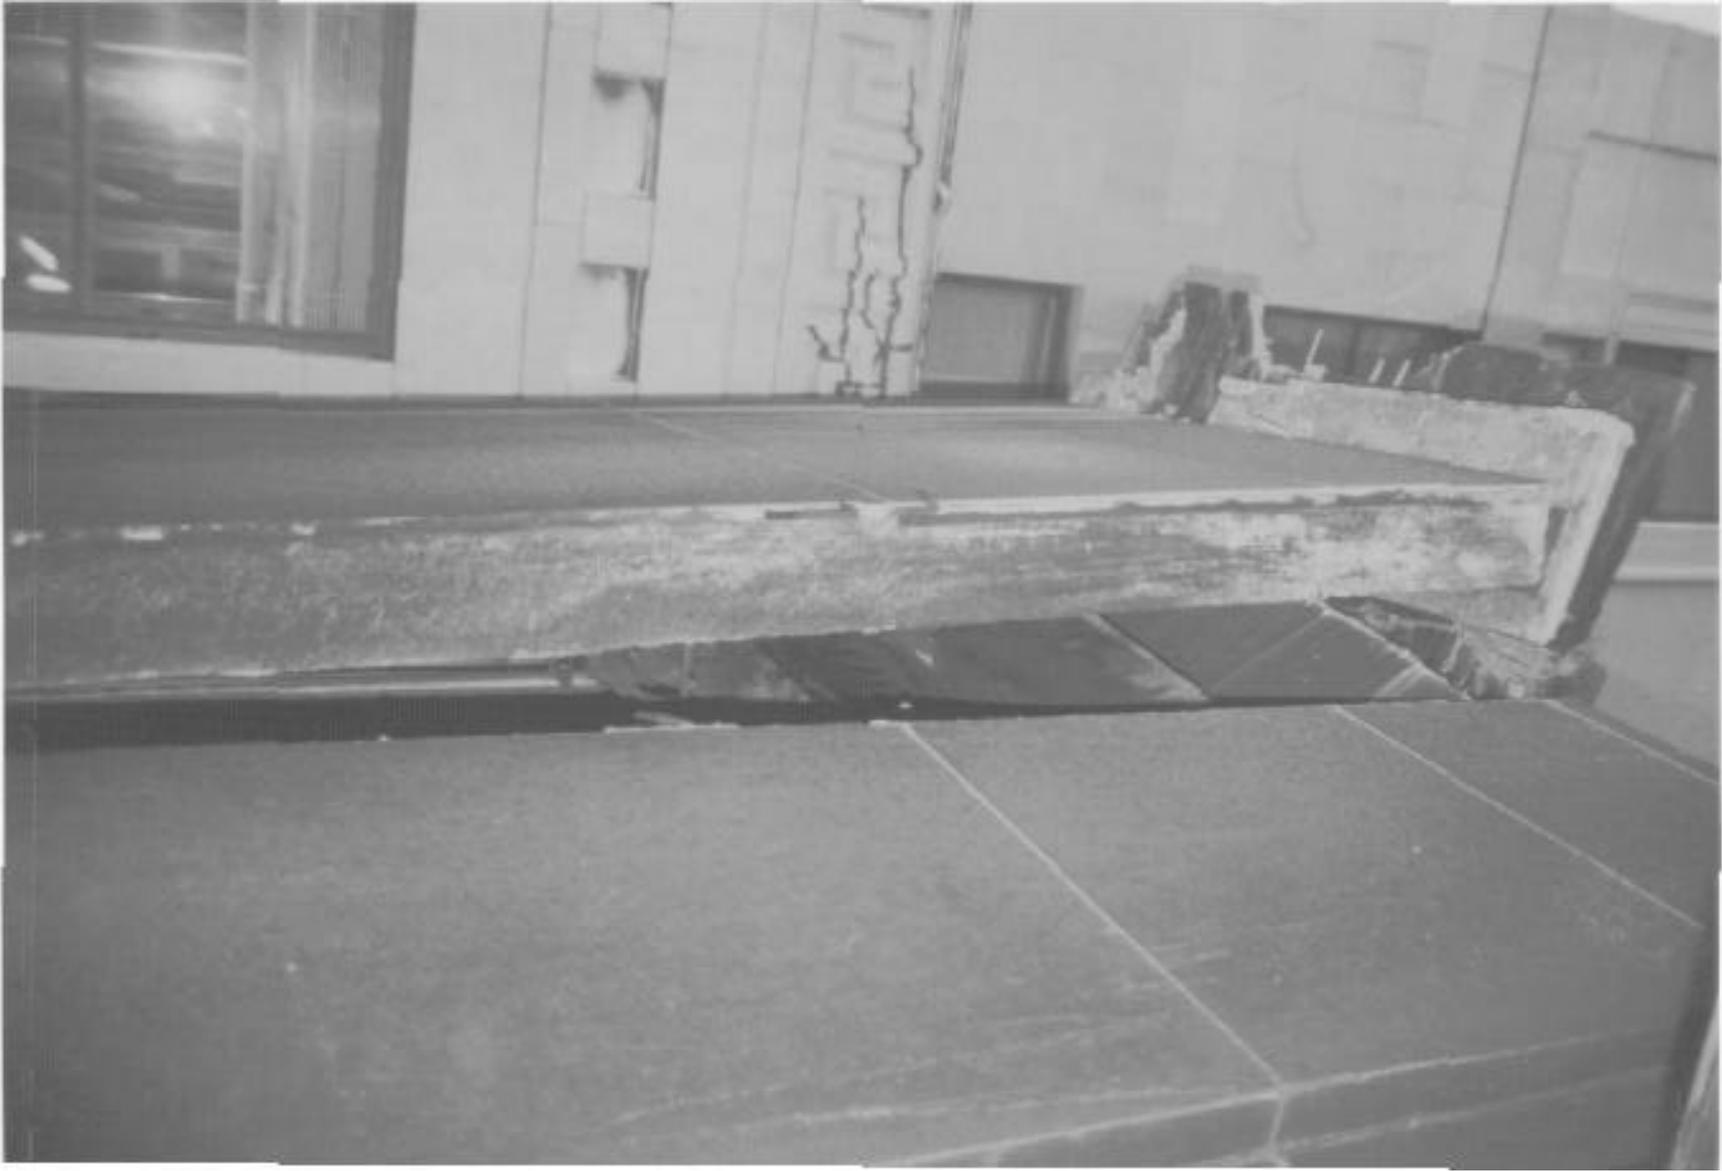
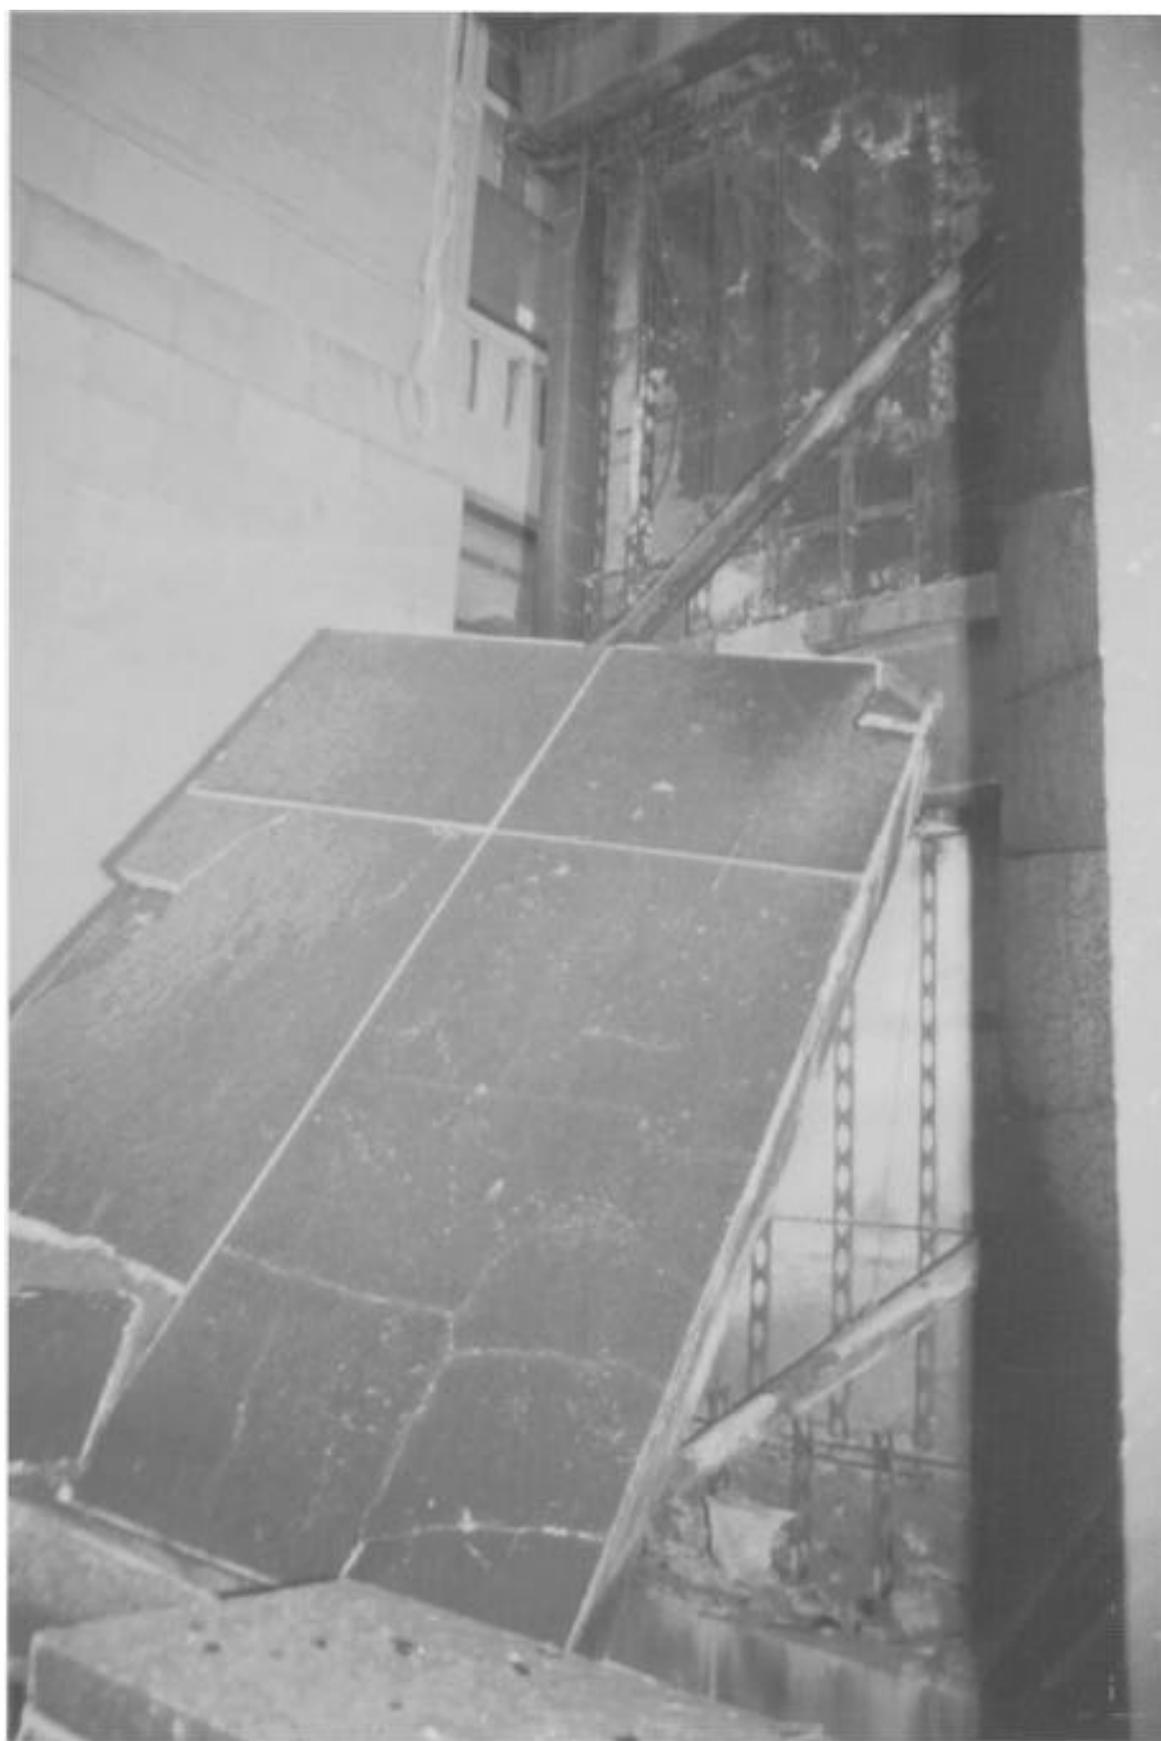
Here and in the next two photos exterior granite panels from the east stair tower were dislodged due to the thermal expansion of the steel frame of the building.

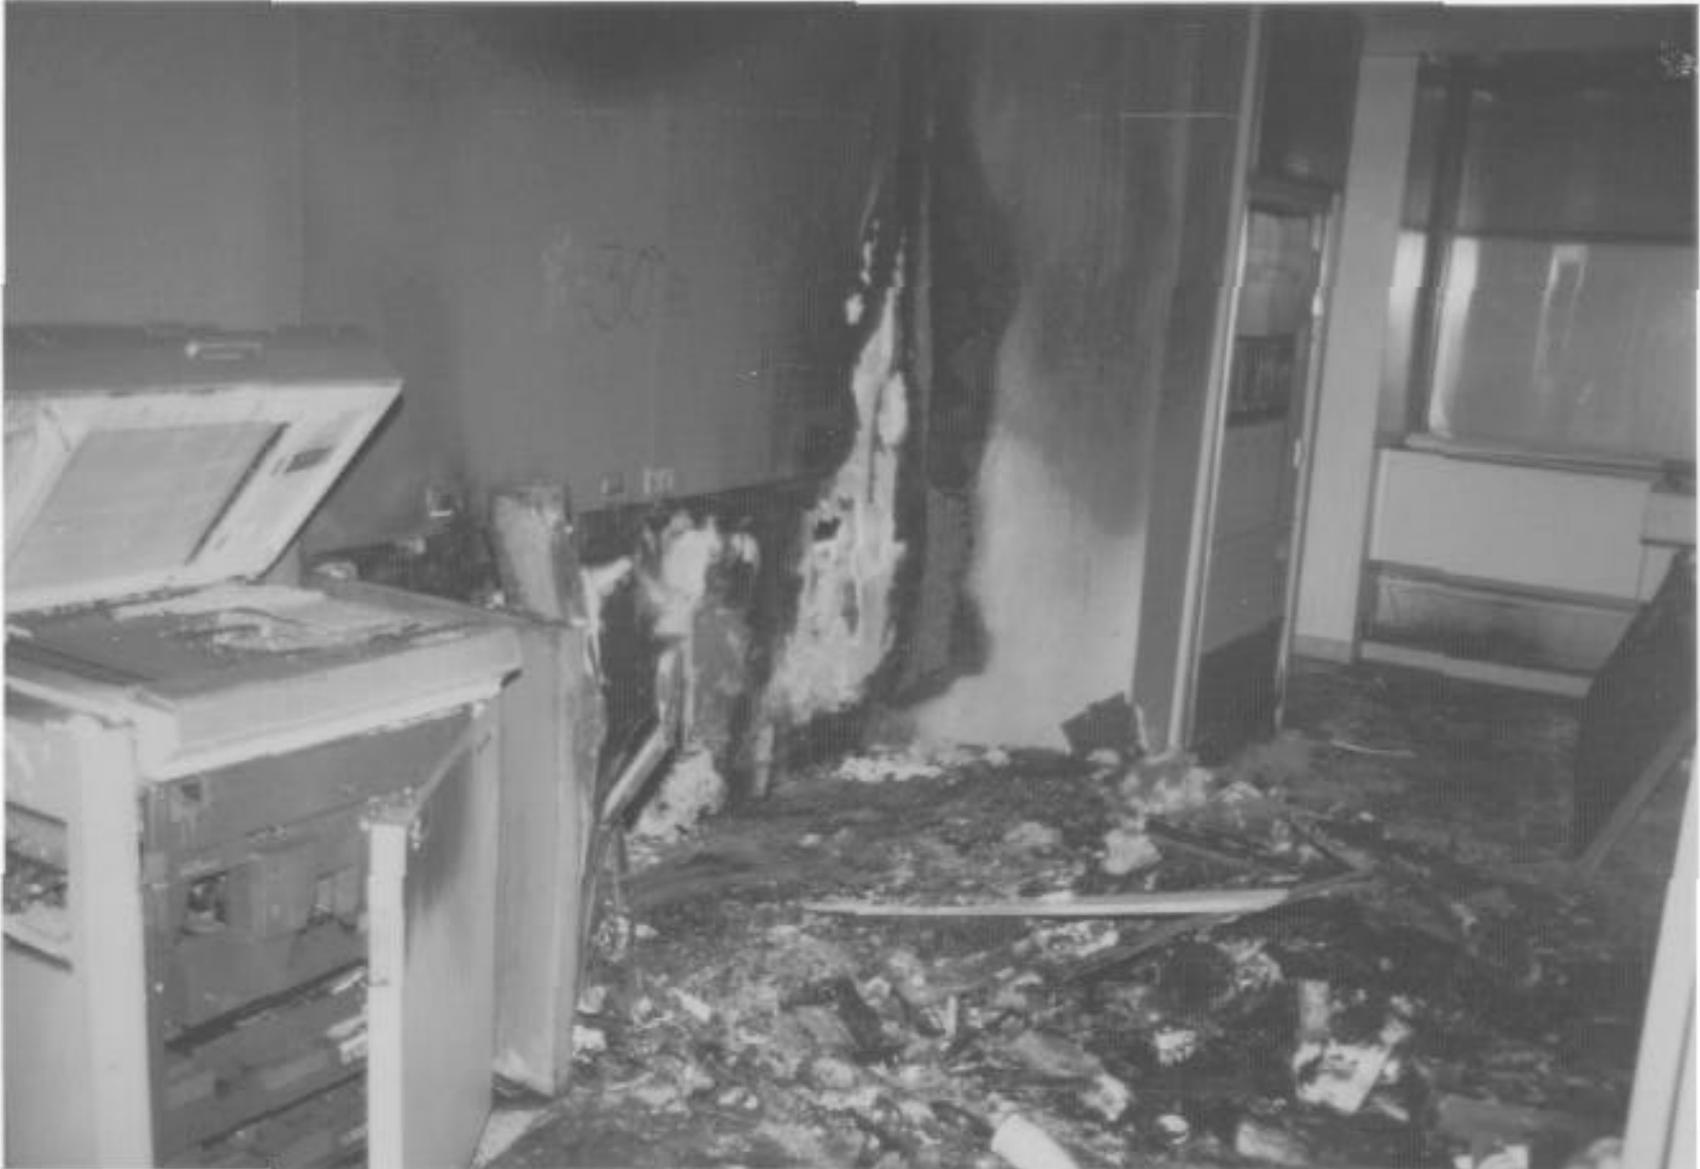
One of the areas of fire penetration on the 30th floor where a single sprinkler head activated to stop the upward extension of the fire.

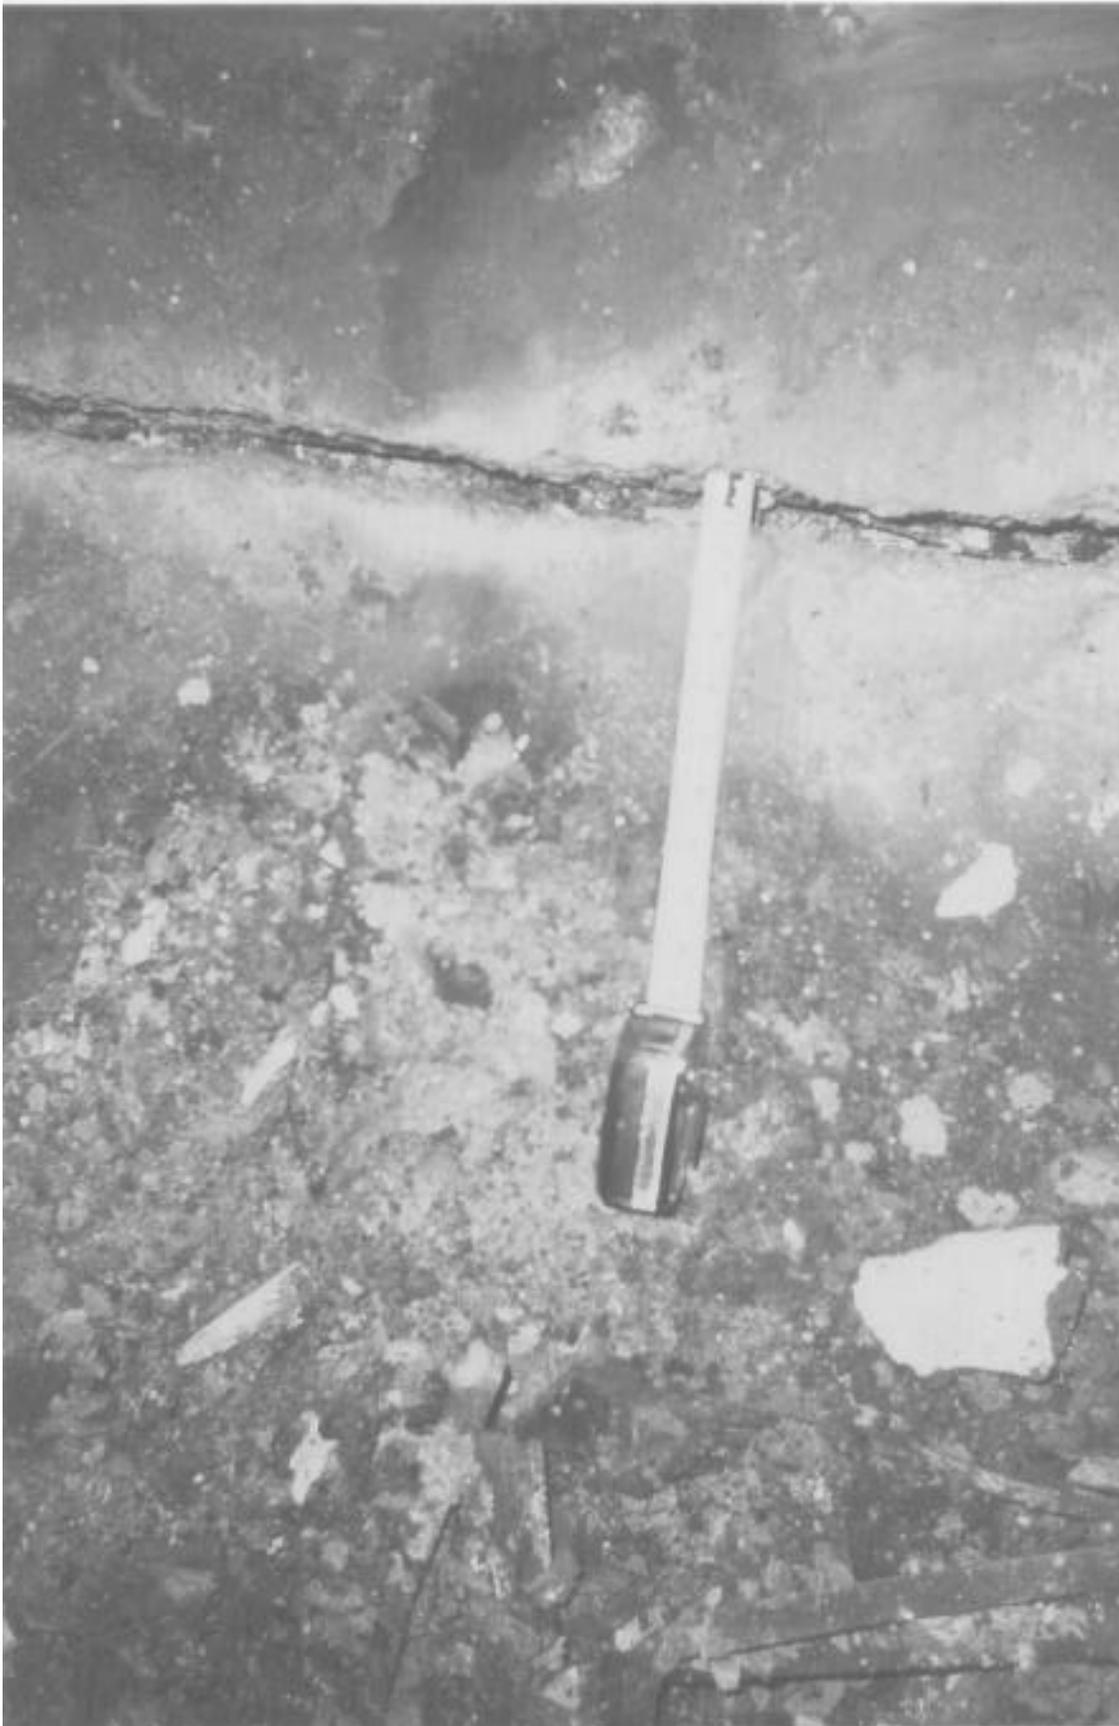
Prior to deciding to evacuate the building, firefighters noticed significant structural displacement occurring in the stair enclosures. A command officer indicated that cracks large enough to place a man's fist through developed at one point. One of the granite exterior wall panels on the east stair enclosure was dislodged by the thermal expansion of the steel framing behind it. After the fire, there was evident significant structural damage to horizontal steel members and floor sections on most of the fire damaged floors. Beams and girders sagged and twisted -- some as much as three feet -- under severe fire exposures, and fissures developed in the reinforced concrete floor assemblies in many places. Despite this extraordinary exposure, the columns continued to support their loads without obvious damage.

Close-up of crack in concrete floor, 28th floor.

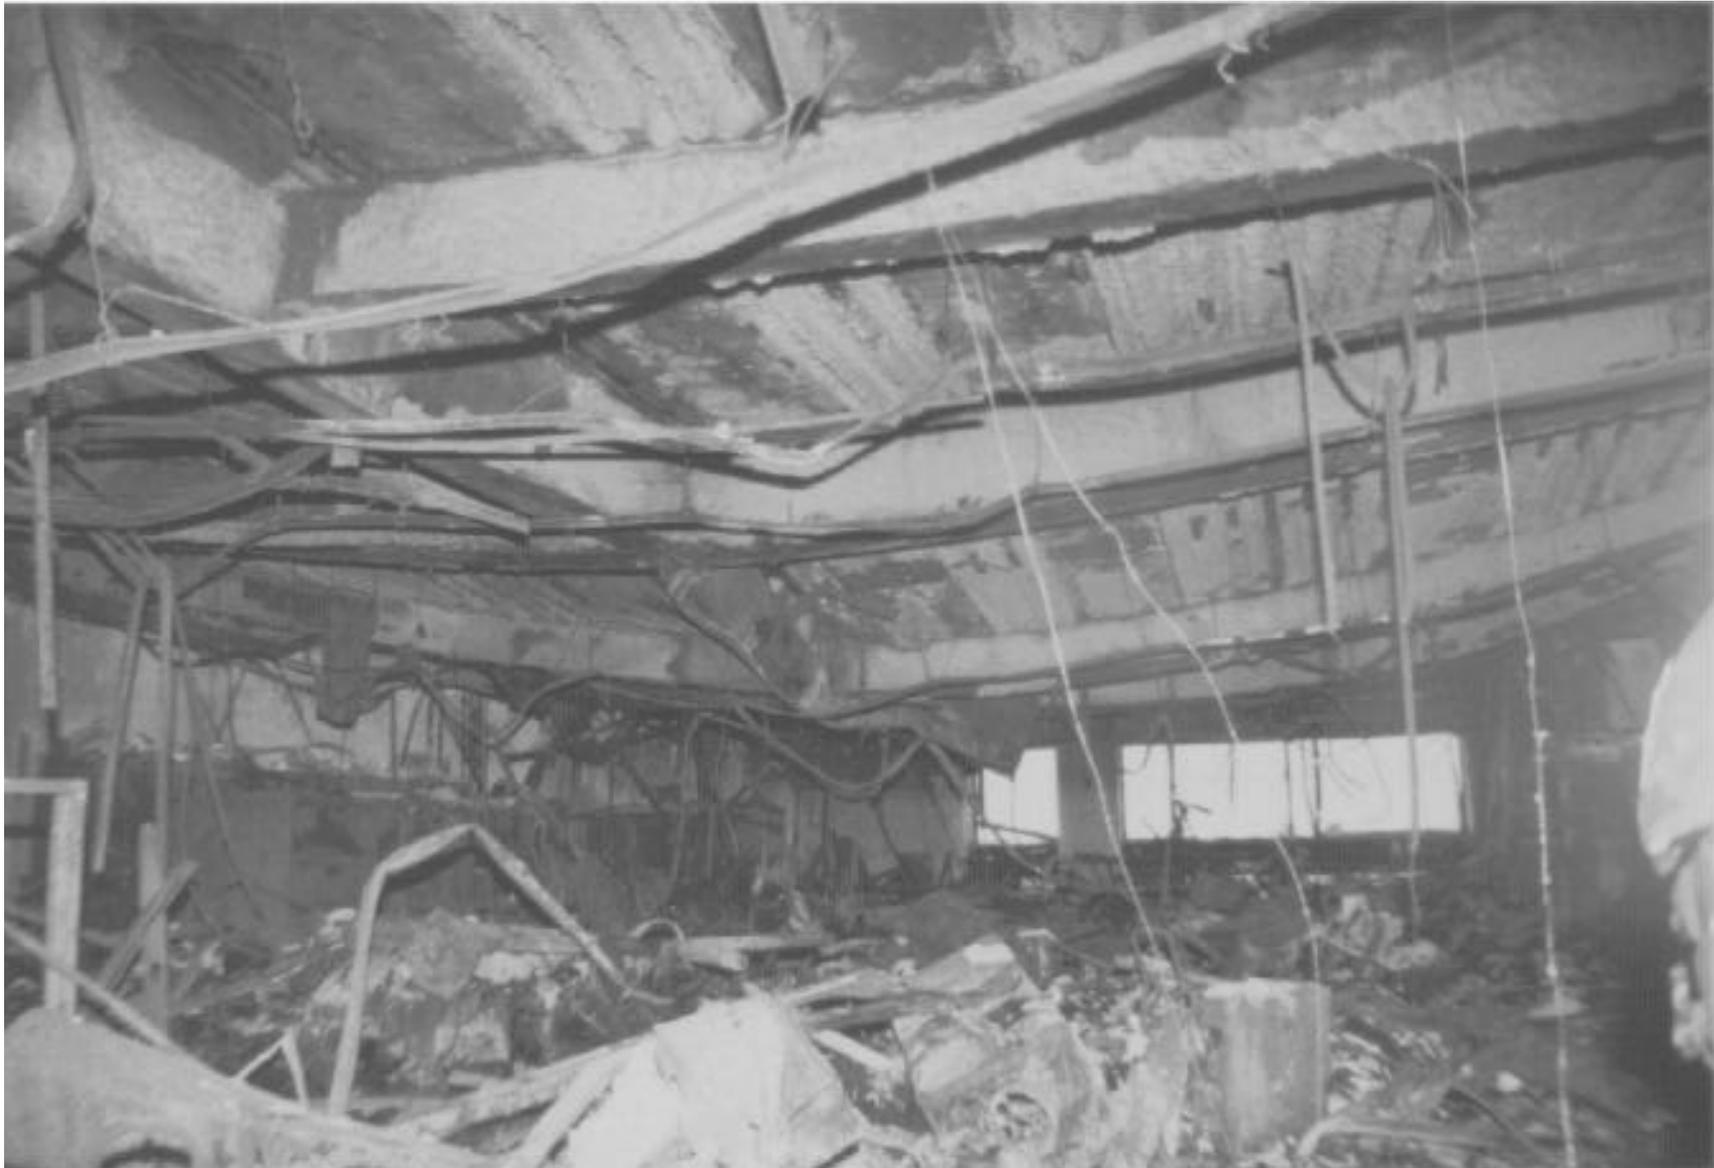
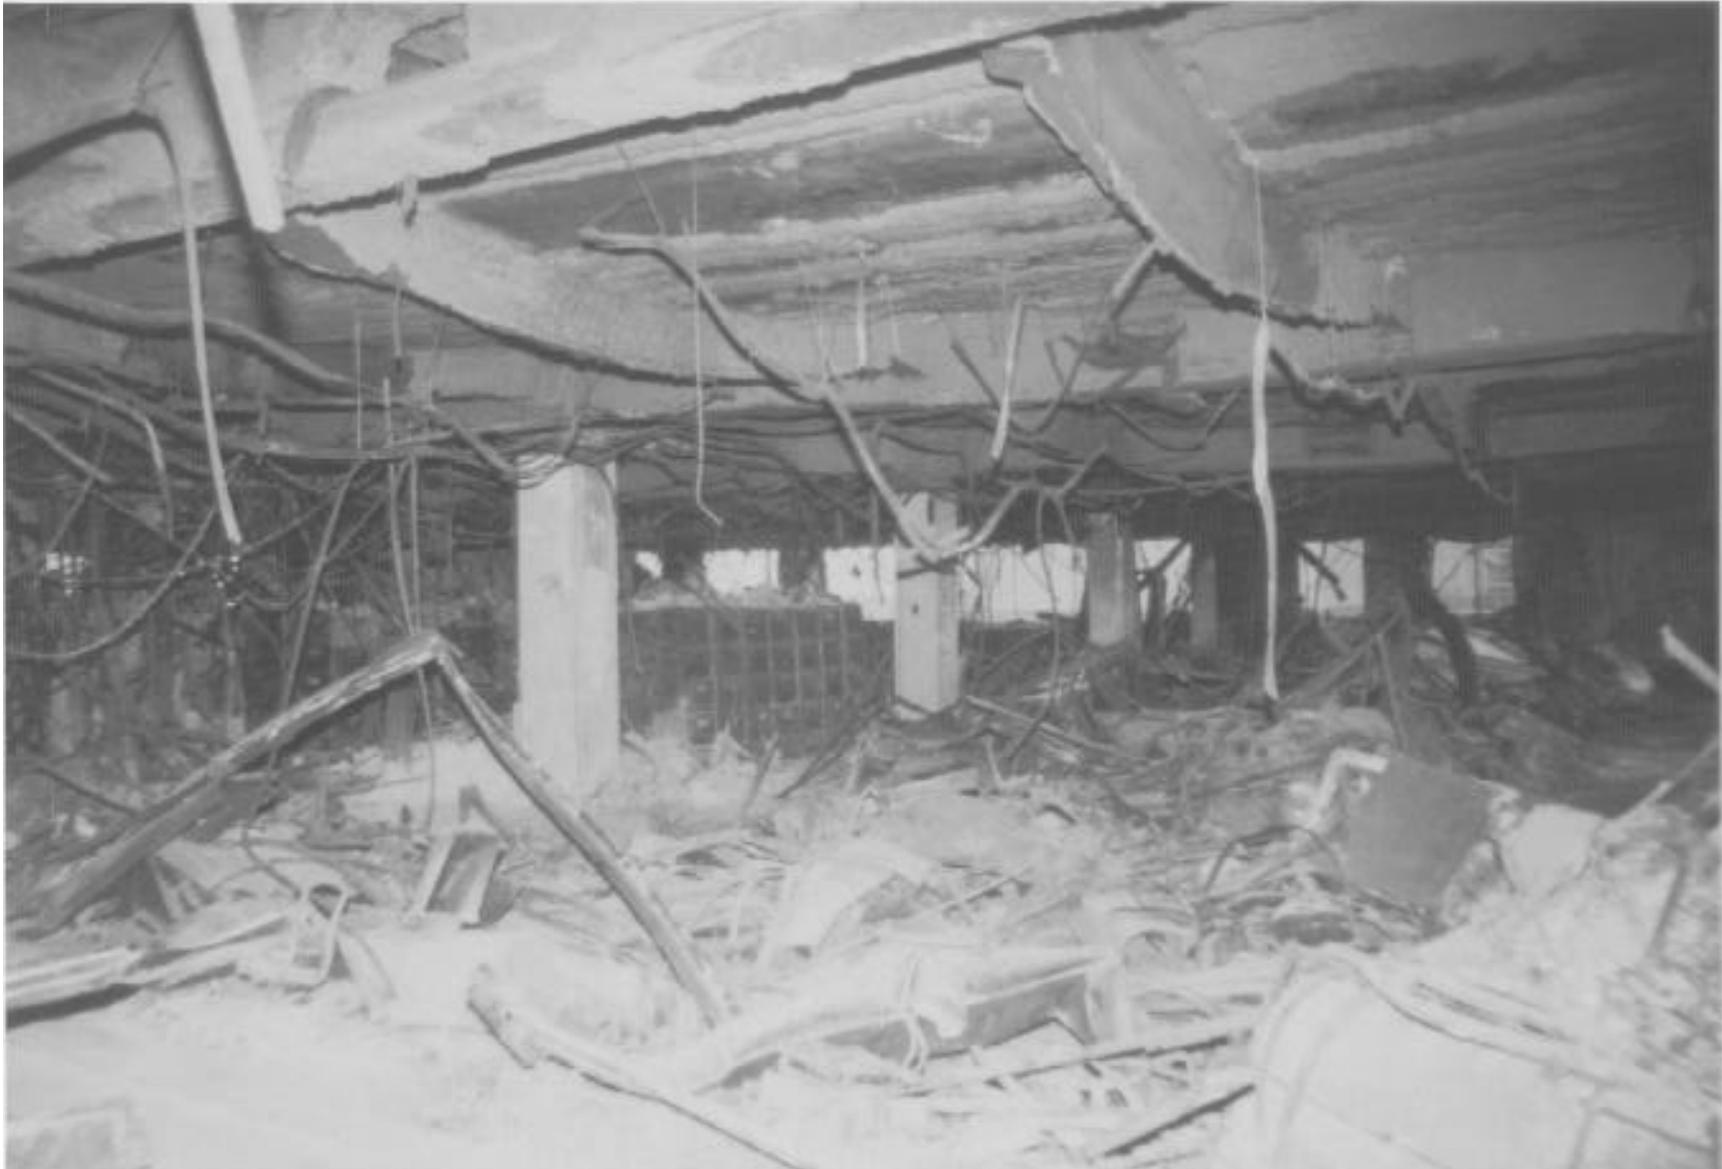
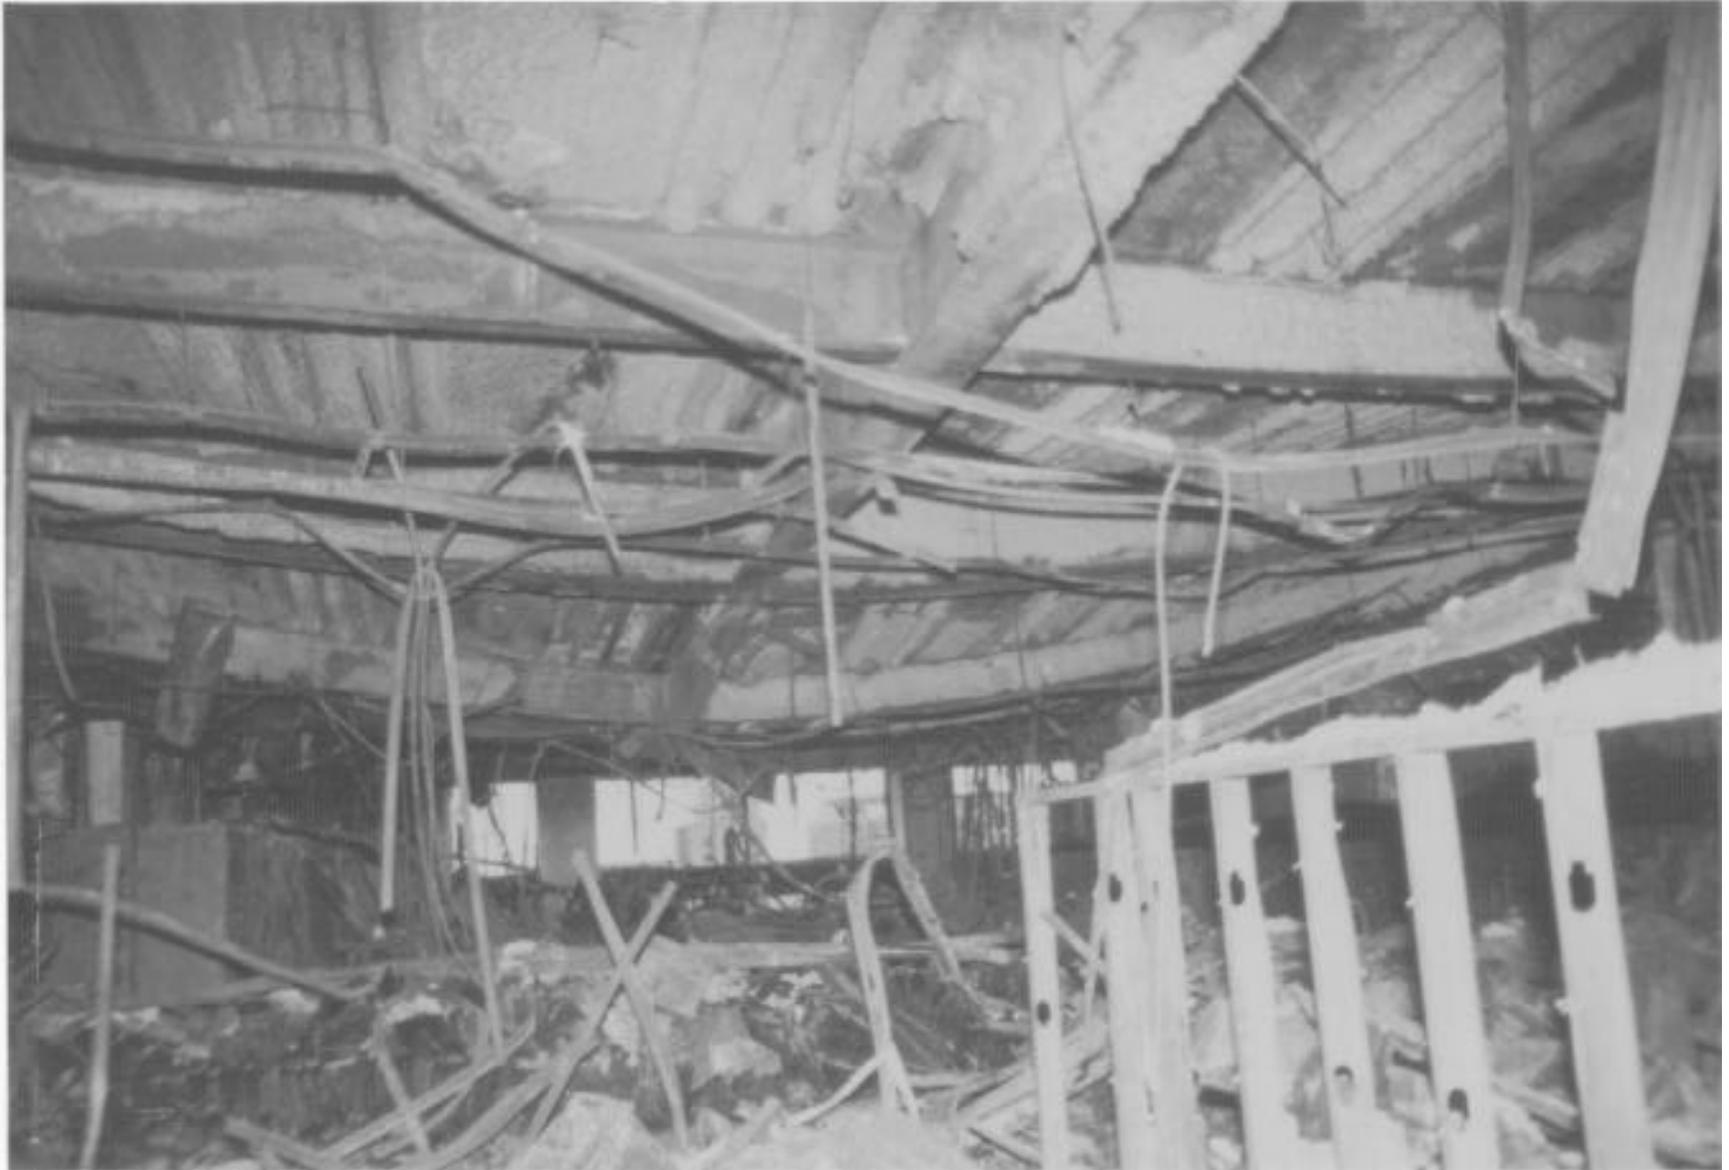
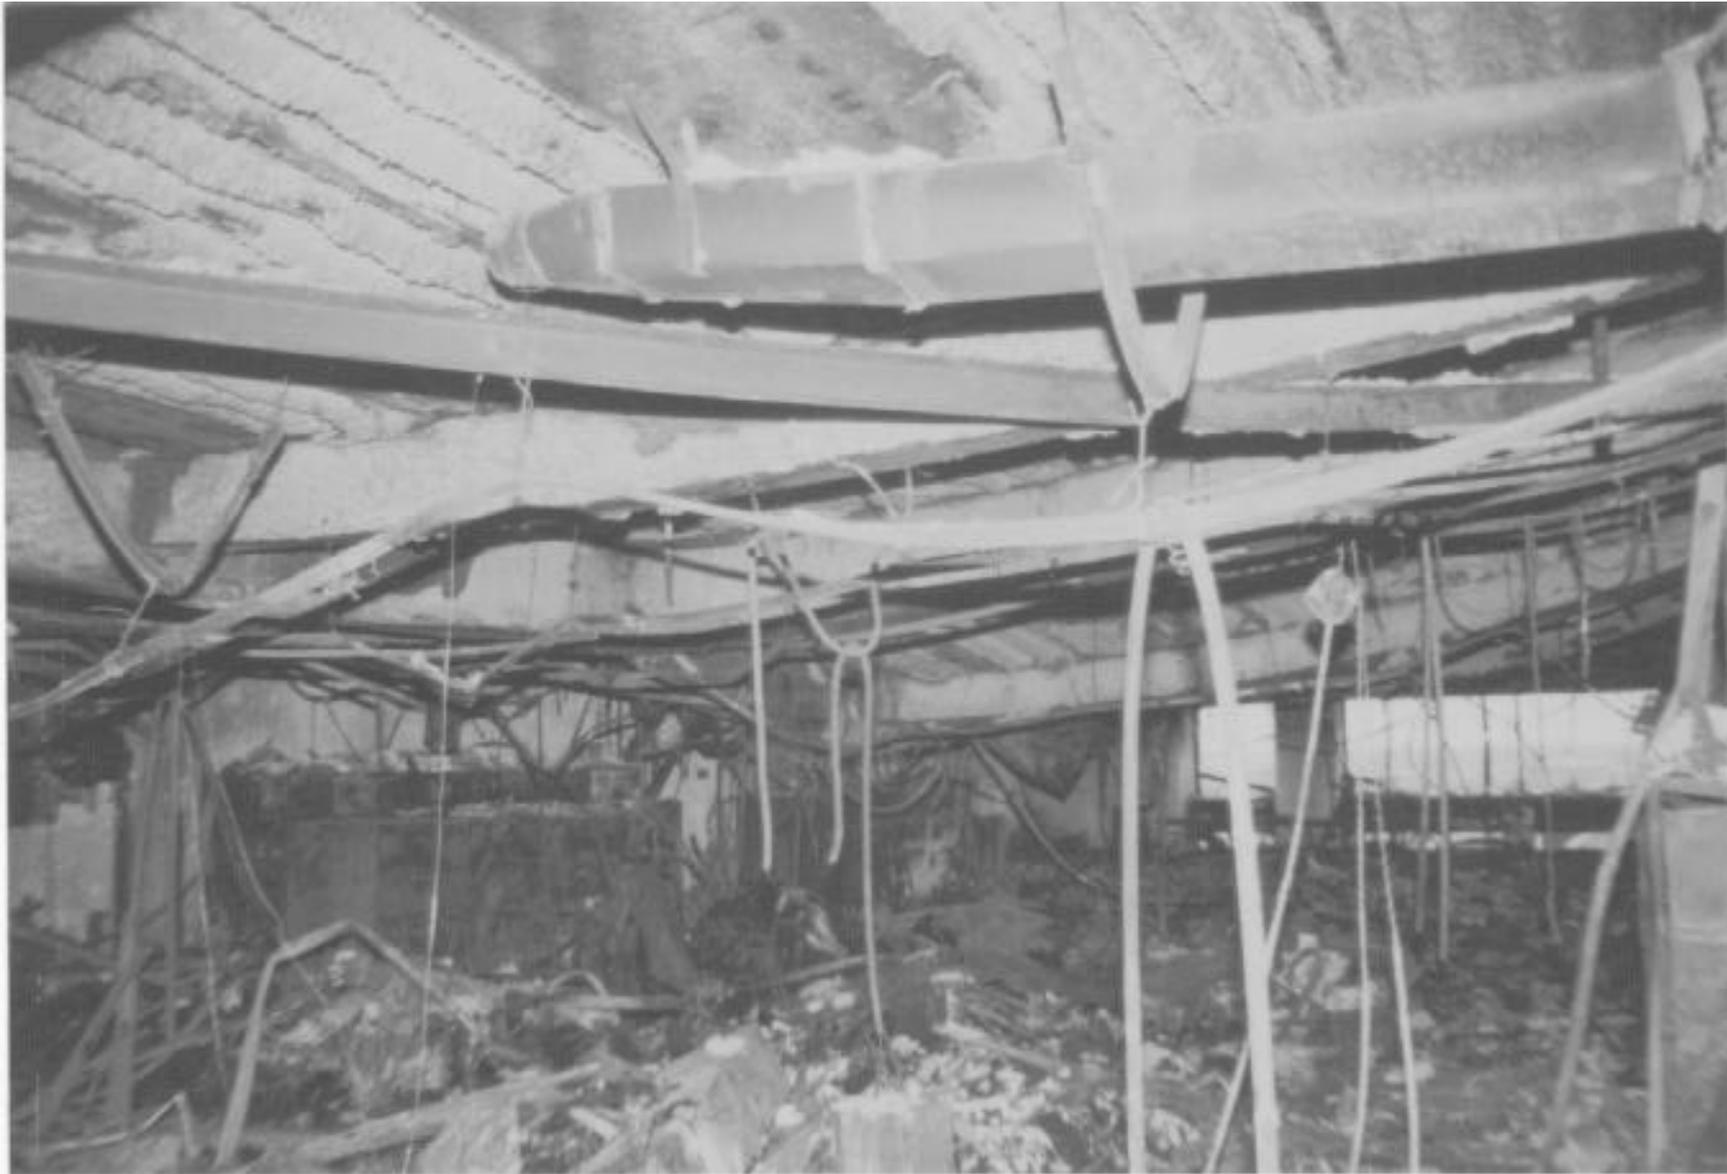
Here and in the next three photos are interior views of floor areas after the fire. Note the total consumption of the available fuel and sagging of the floor deck of up to three feet between columns.

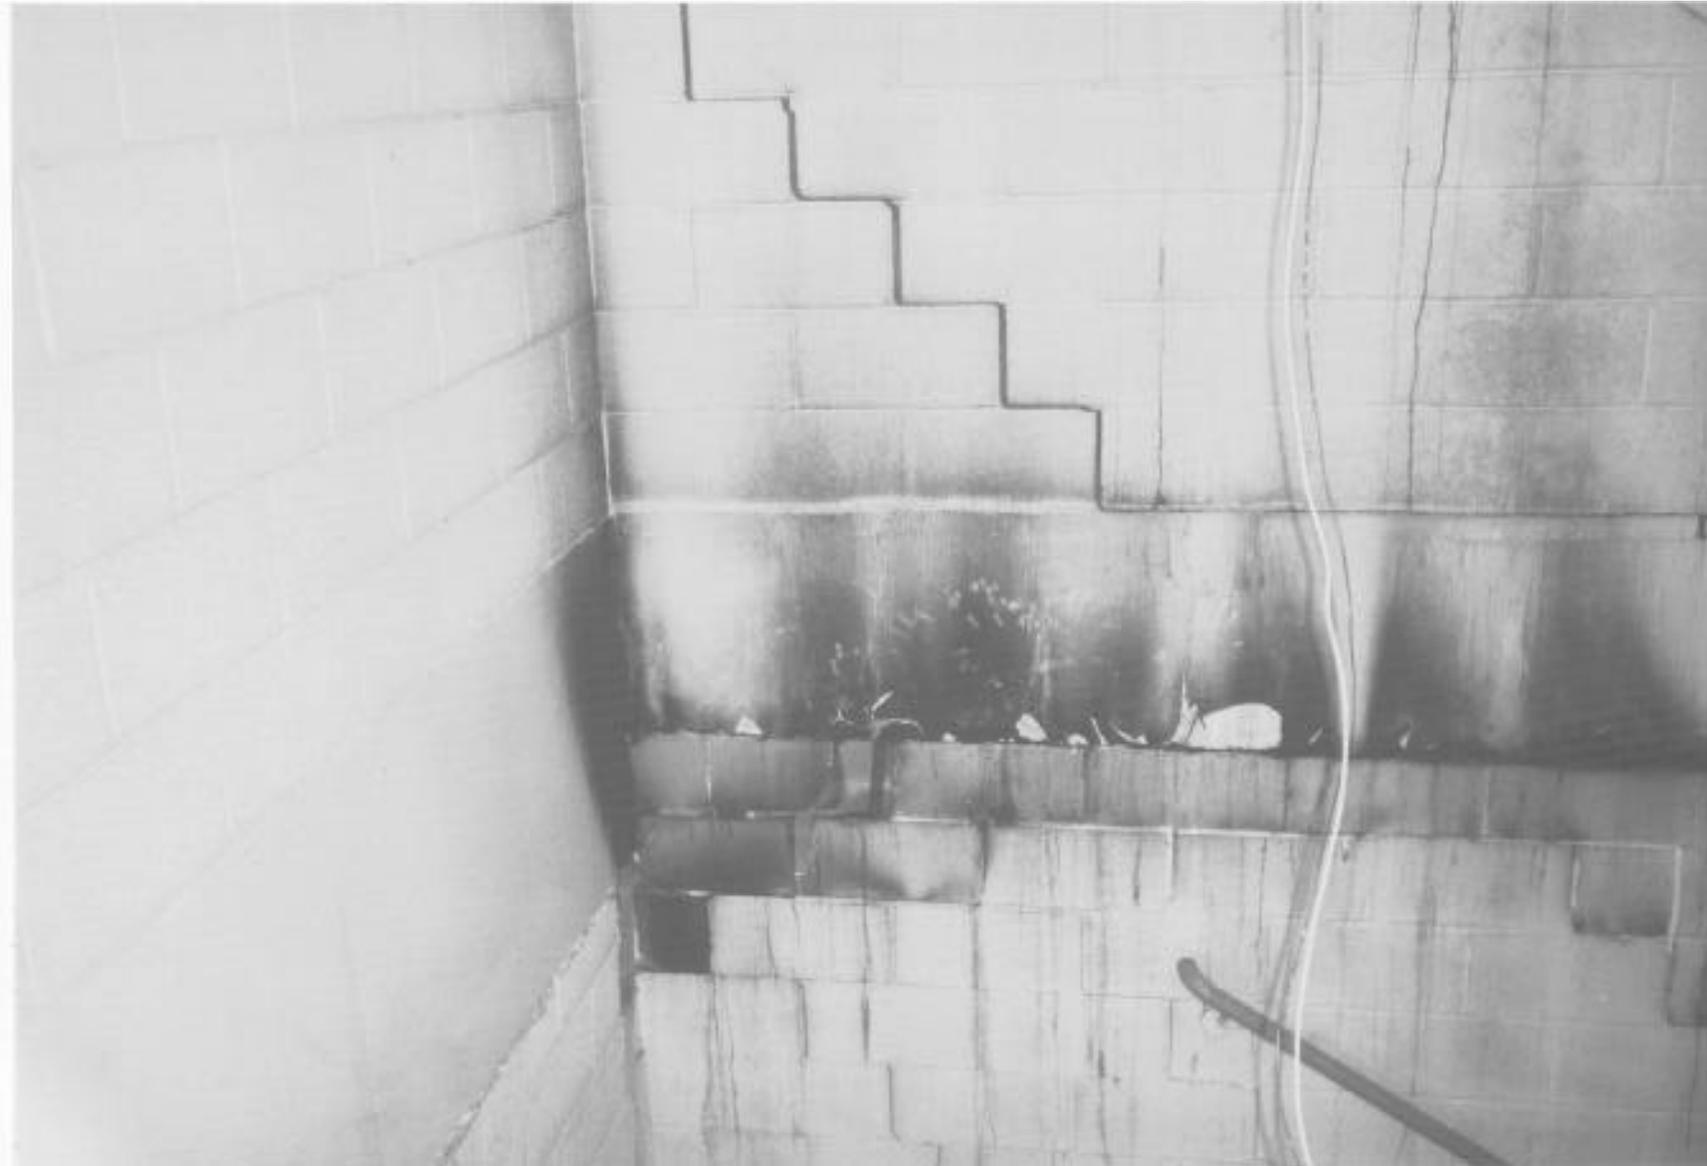
Fire tower between 25th and 26th floors. Note heavy fire and smoke damage.

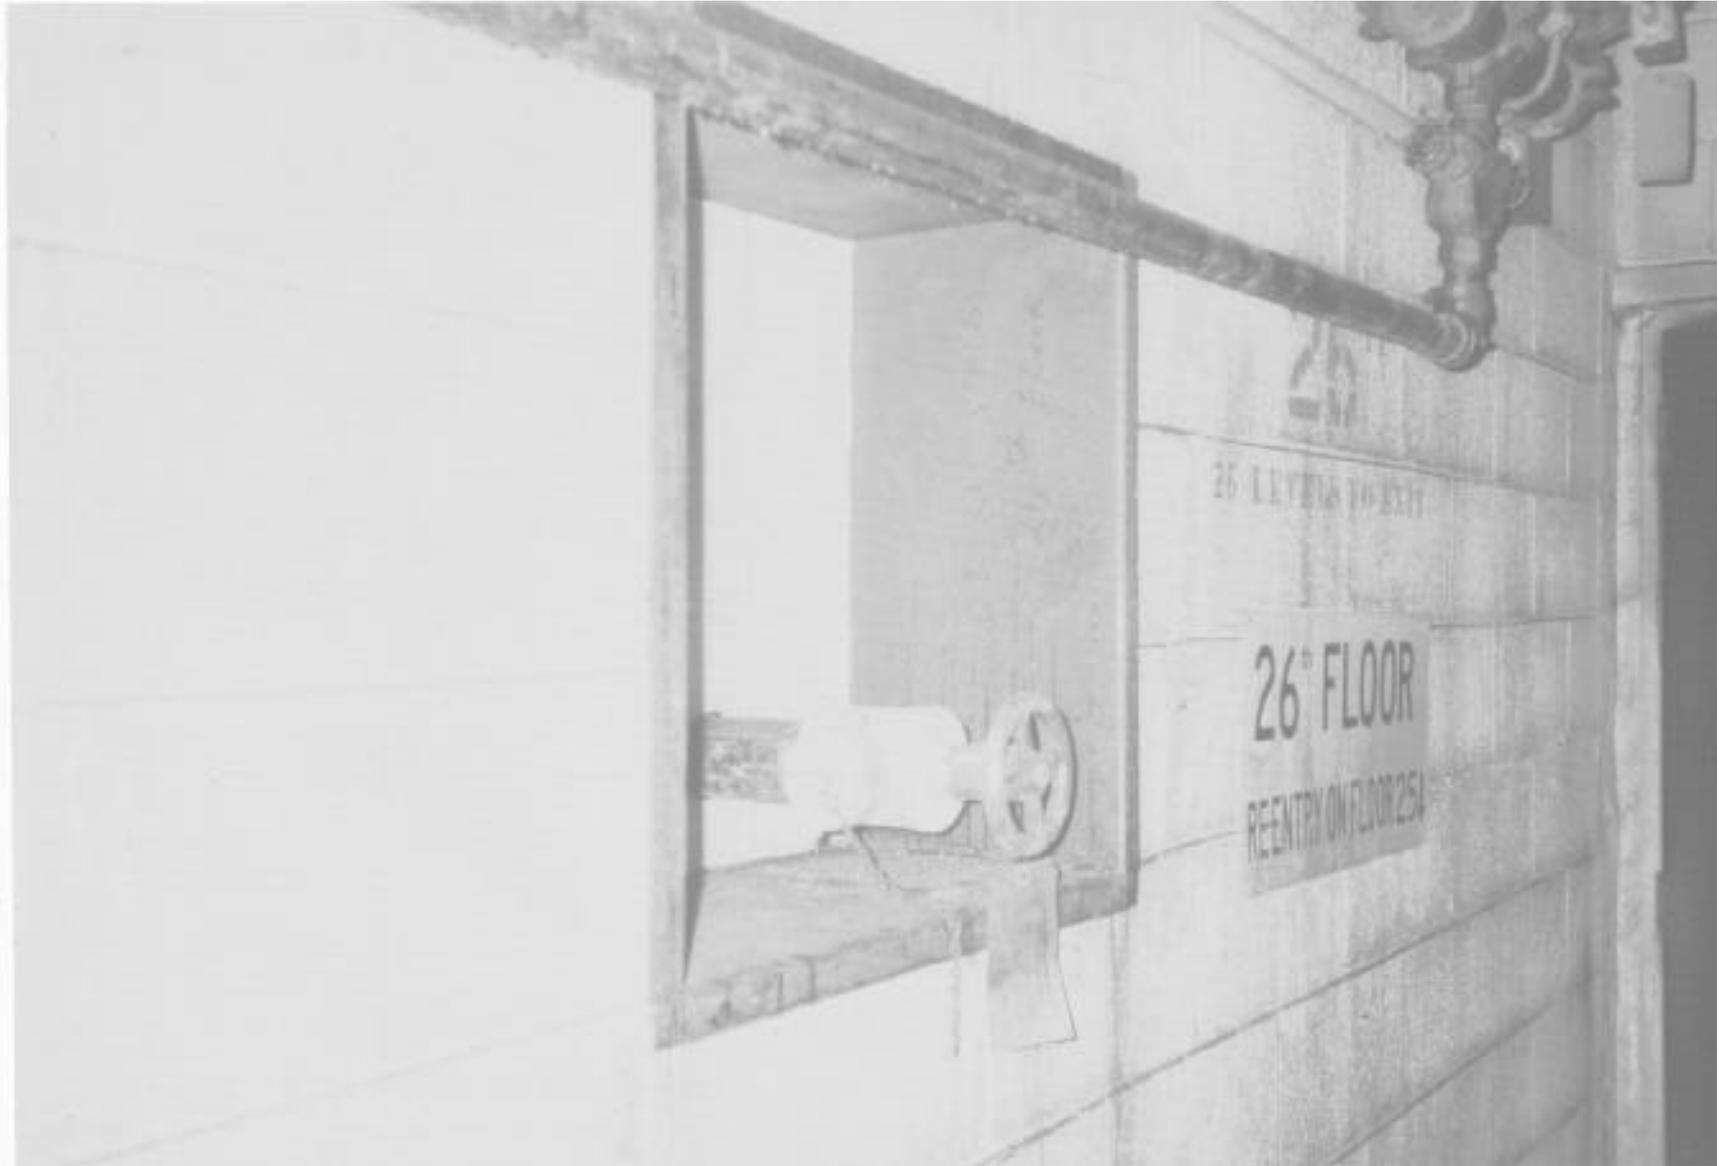
When the PRVs were originally installed, the pressure settings were improperly adjusted. Index values marked on the valves did not correspond directly to discharge pressures. To perform adjustments the factory and field personnel had to refer to tables in printed installation

The PRV equipped hose outlets on the 22nd floor of One Meridian Plaza, adjusted as reported at the time of the fire, would have produced nozzle pressures of approximately 40 psi. This is insufficient for a straight stream device and dangerously inadequate for a fog nozzle.

Standpipe hose outlet with pressure reducing valve (PRV), 26th floor.
