# United States Fire Administration

### High-rise Office Building Fire One Meridian Plaza Philadelphia, Pennsylvania

## United States Fire Administration Fire Investigations Program

This report on the Philadelphia, Pennsylvania, One Meridian Plaza fire documents one of the most significant high-rise fires in United States' history. The fire claimed the lives of three Philadelphia firefighters and gutted eight floors of a 38-story fire-resistive building causing an estimated \$100 million in direct property loss and an equal or greater loss through business interruption. Litigation resulting from the fire amounts to an estimated \$4 billion in civil damage claims. Twenty months after the fire this building, one of Philadelphia's tallest, situated on Penn Square directly across from City Hall, still stood unoccupied and fire-scarred, its structural integrity in question.

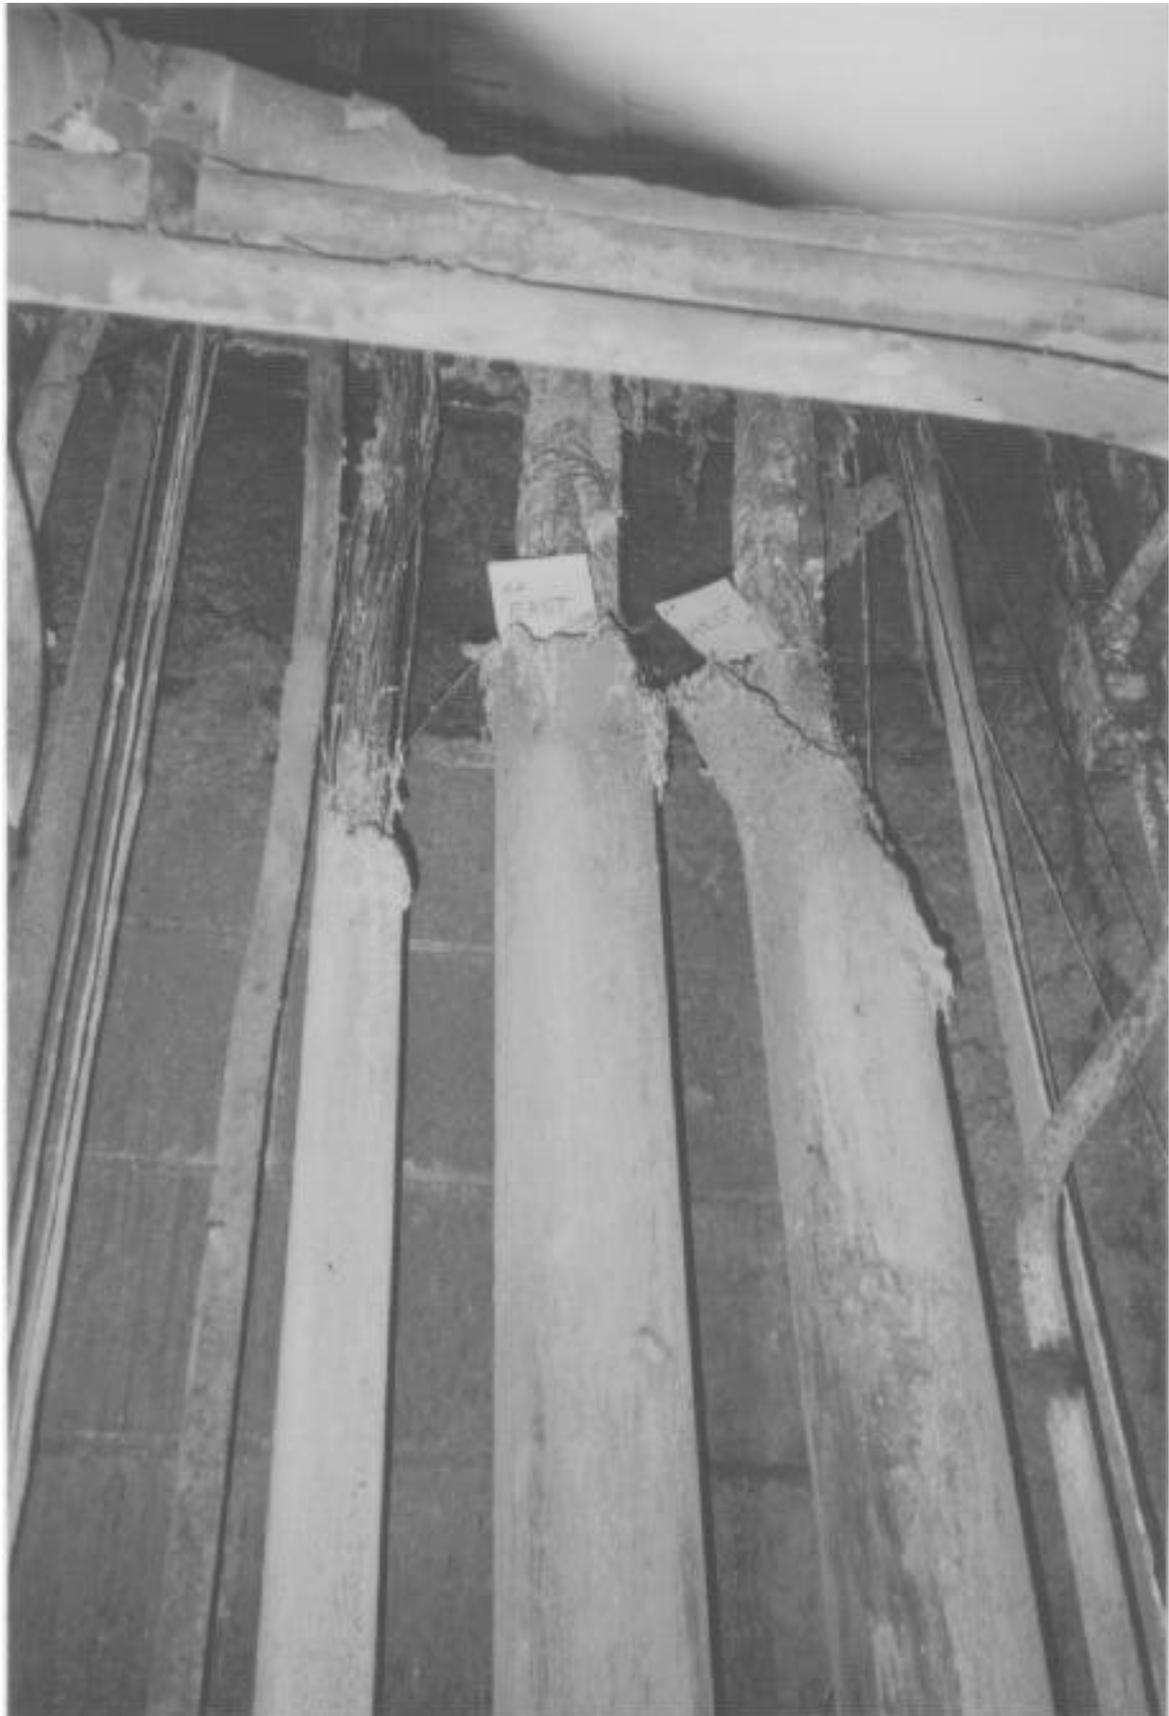
<b>Electrical Systems</b>	Installation of the primary and secondary electrical power risers in a common unprotected enclosure resulted in a complete power failure when the fire-damaged conductors shorted to ground. The natural gas powered emergency generator also failed.

Shortly after the battalion chief and the attack team reached the 11th floor there was a total loss of electrical power in the building. This resulted when intense heat from the fire floor penetrated the electrical room enclosure. The heat caused the cable insulation to melt resulting in a &ad short between the conductor and the conduit in both the primary and secondary power feeds, and the loss of both commercial power sources. The emergency generator should have activated automatically, but it failed to produce electric power. These events left the entire building without electricity for the duration of the incident in spite of several efforts to restore commercial power and to obtain power from the generator.

Electrical shaft enclosure on the 30th floor, showing side-by-side risers for the two power supplies, both damaged by fire penetration at the plenum level of the adjoining office space.

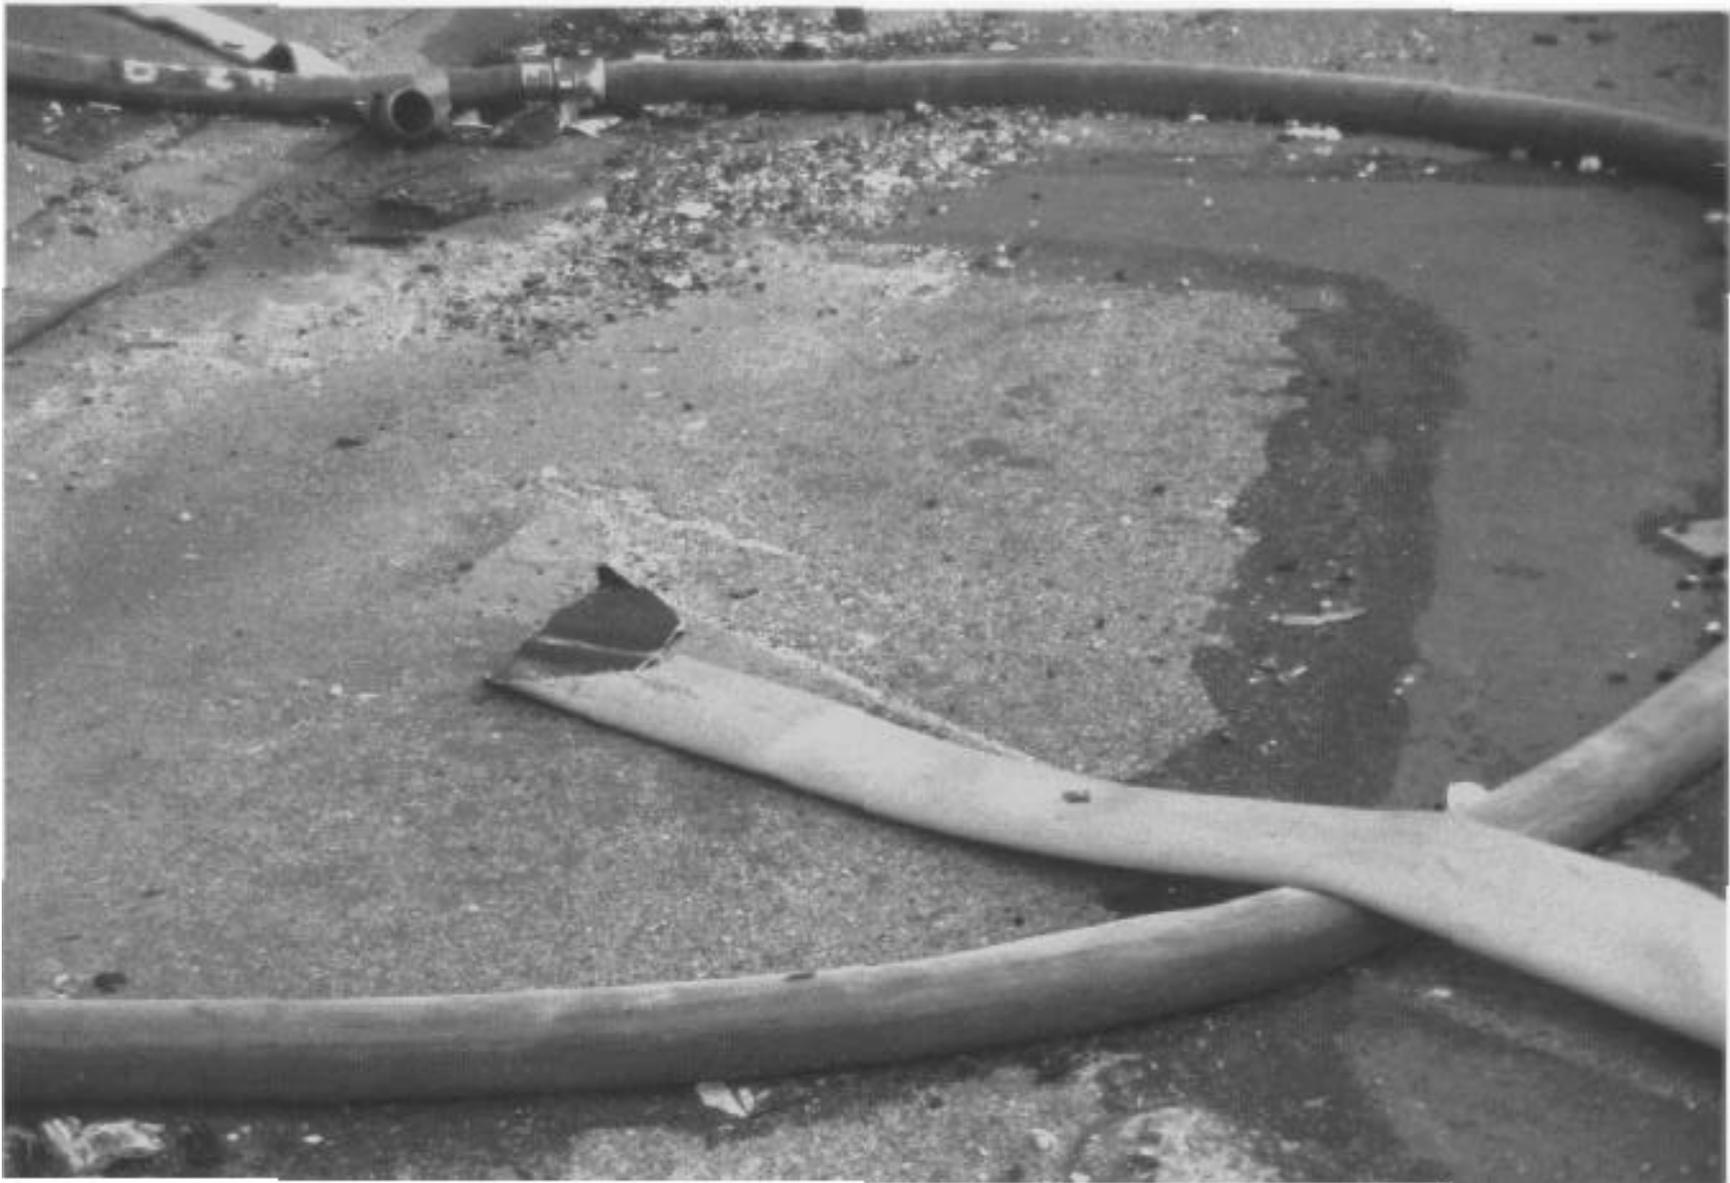
Section of 5-inch hose that was ruptured by falling debris outside the building. Hose lines feeding the standpipes and entering the stairways were damaged several times and had to be replaced at great risk to firefighters.  
(Shoring boards were later used to protect the hose lines.)

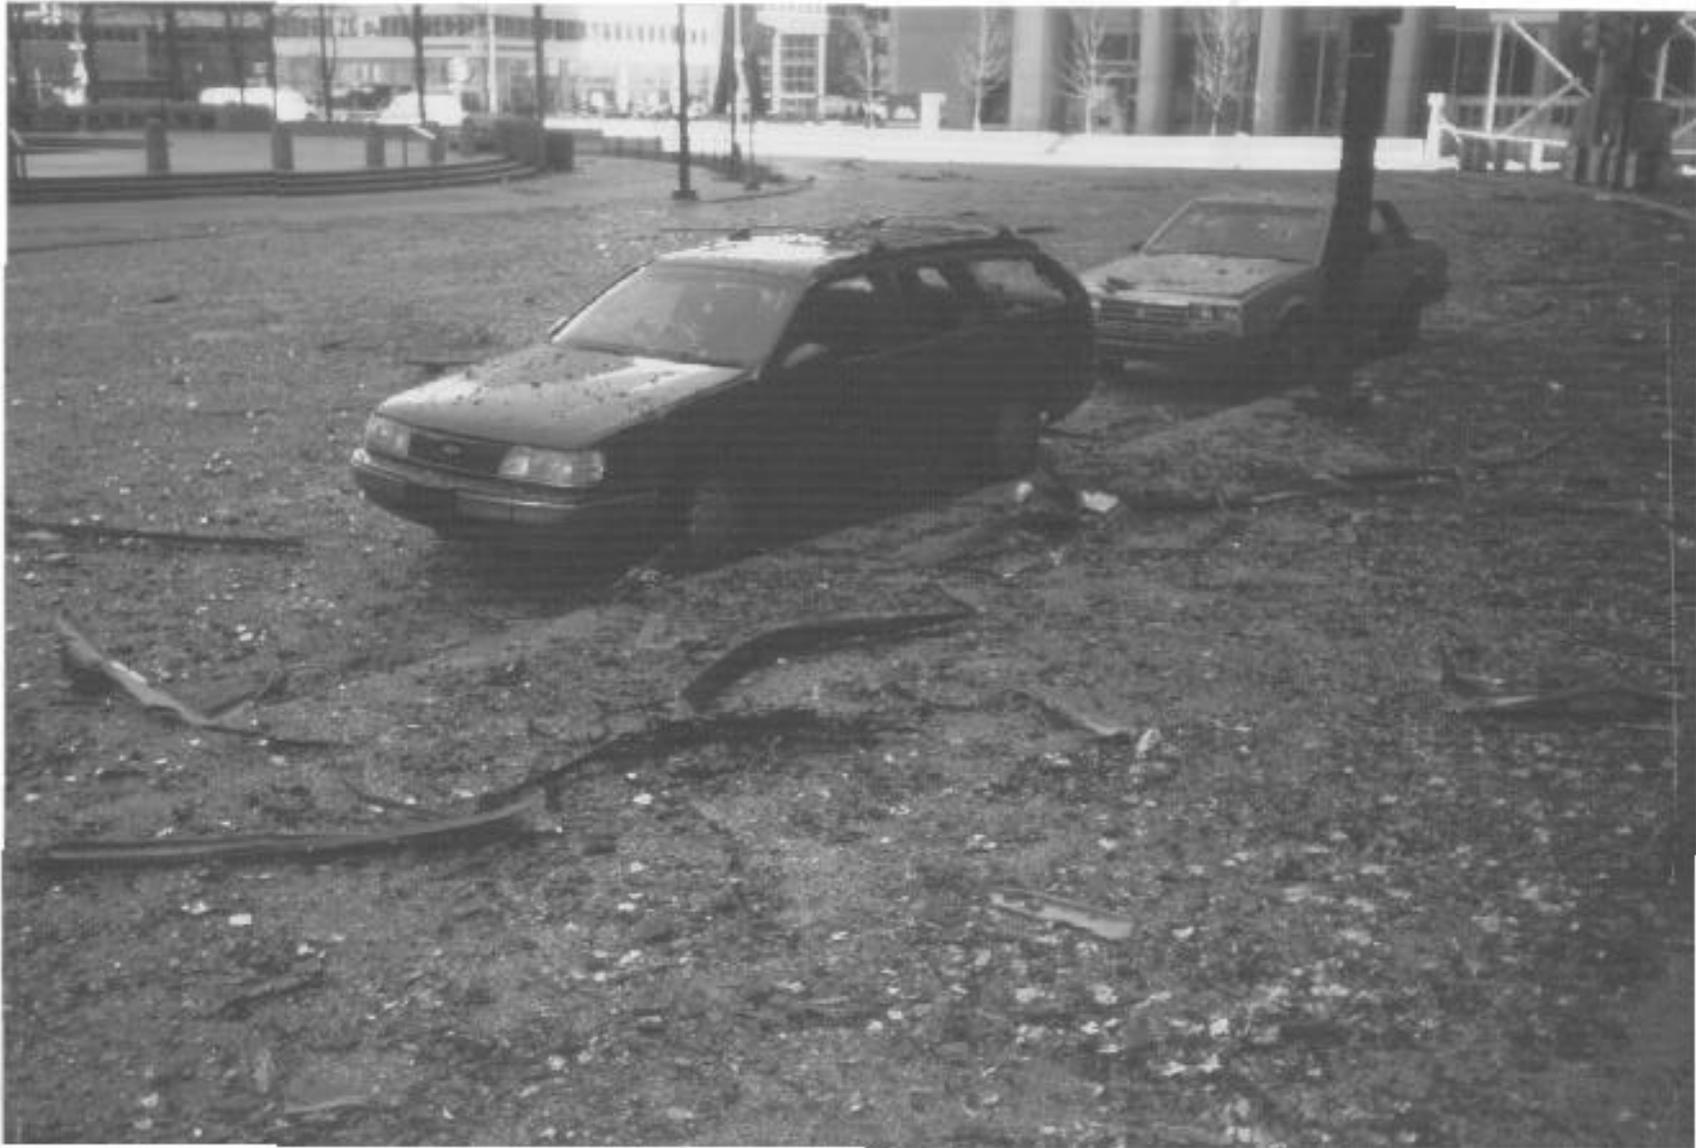
Street in front of the building from front steps showing stranded autos and debris in street.
