Fire Behavior Case Study

This case study was developed using National Institute for Occupational Safety and Health (NIOSH) Death in the Line of Duty Report F2008-06, United States Fire Administration (USFA) Firefighter Line of Duty Death Database, news media reports, and information obtained from the departments involved in the incident.

Figure 1. 132 Garden Avenue-Side Alpha

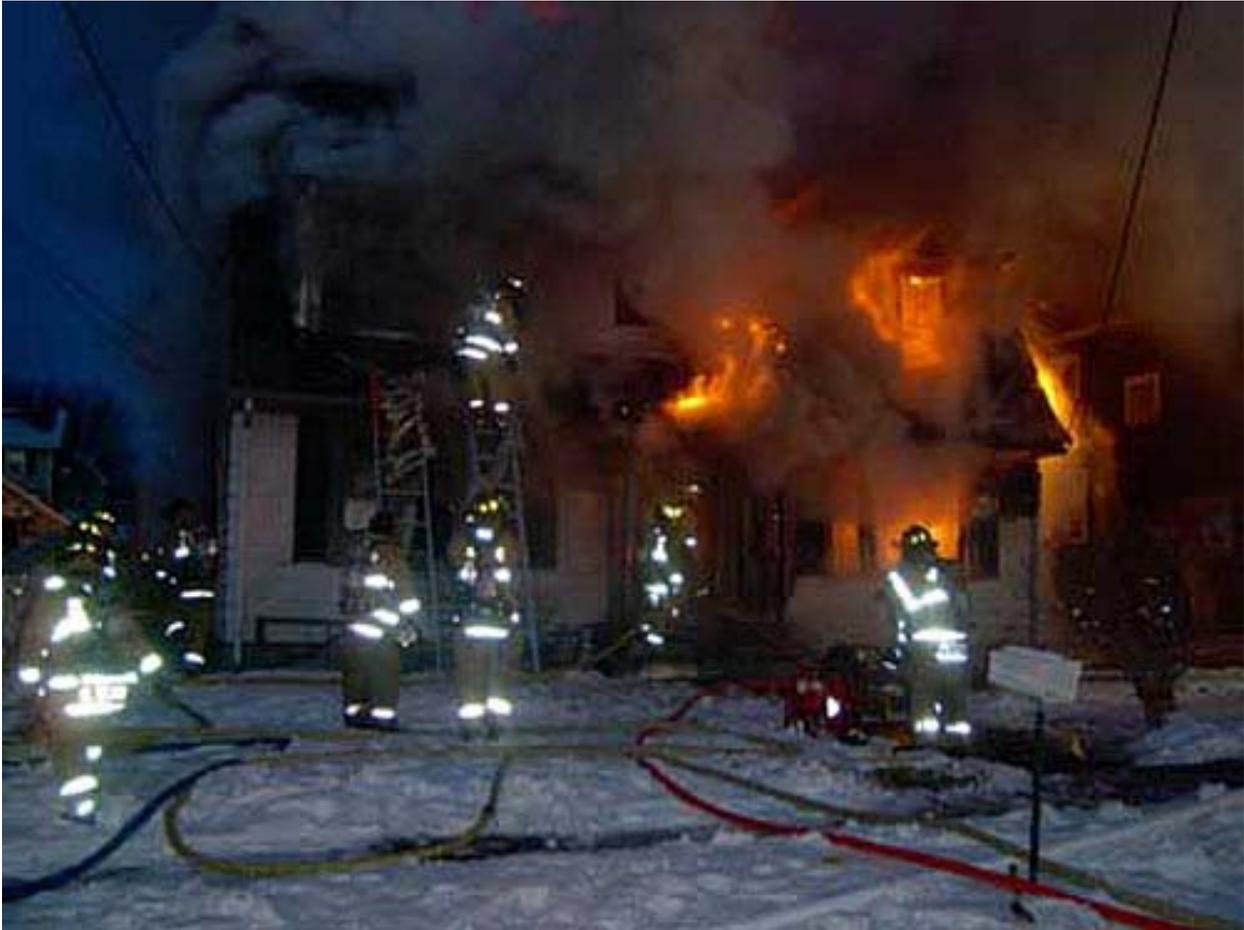
Note: Fire Department Photo - NIOSH Death in the Line of Duty Report F2008-06. This photo likely illustrates conditions after 0635, while Firefighter Holmes and Lieutenant King are searching Floor 2 of Exposure B.

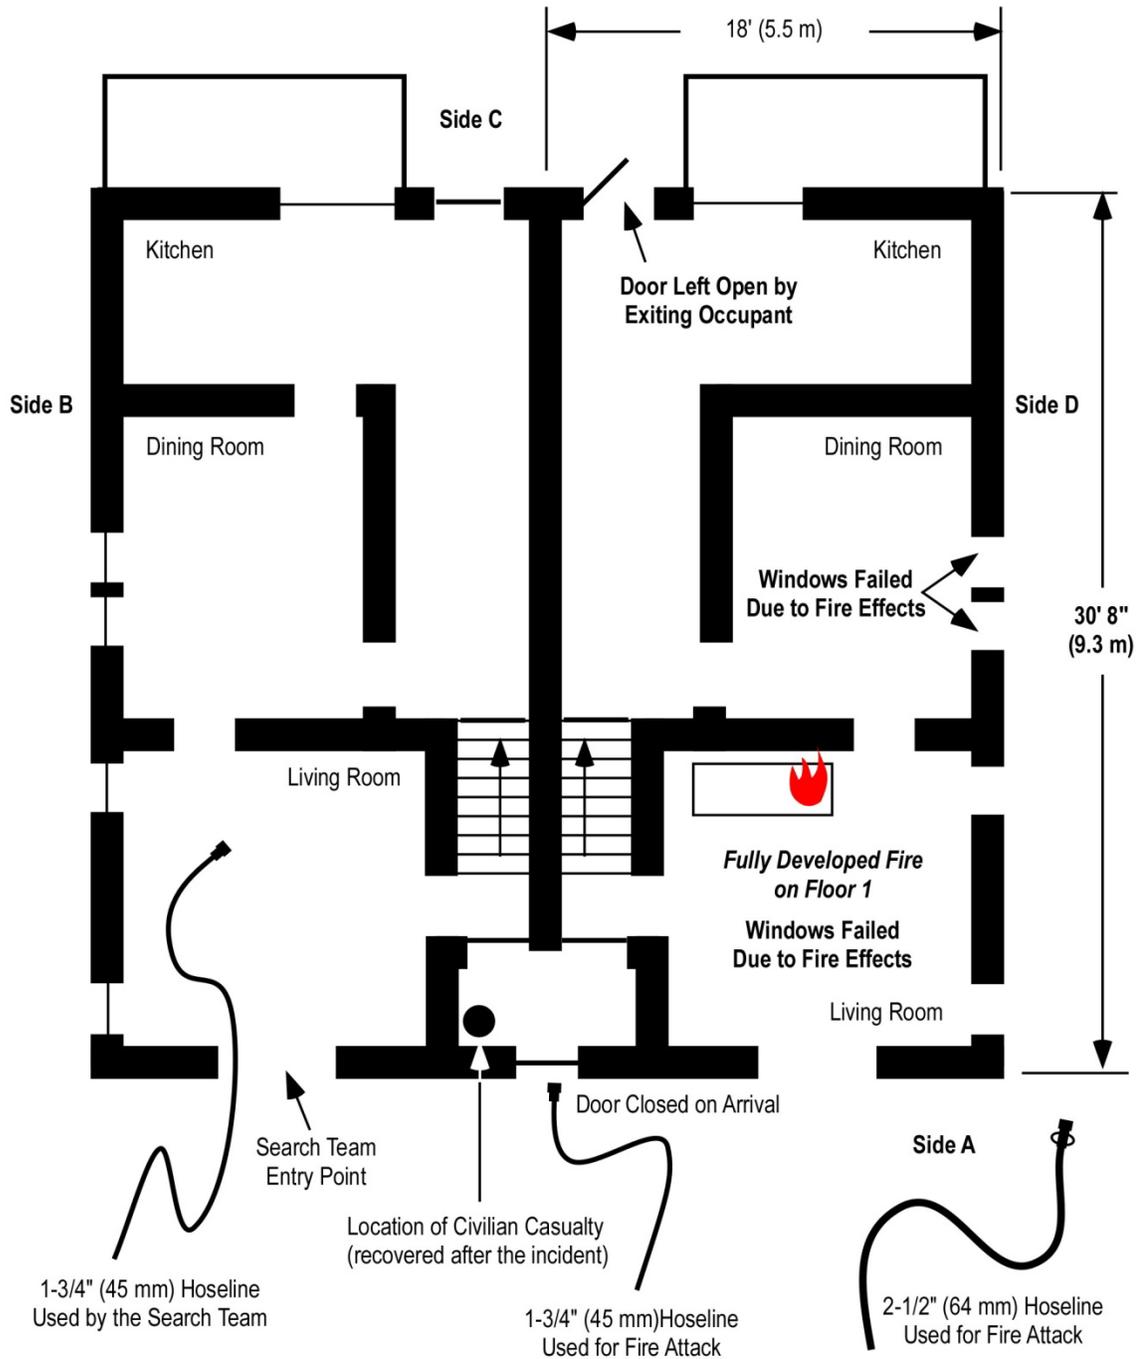
Figure 2. Fire Unit and Exposure Bravo Floor 1

As illustrated in Figures 2 and 3, the floor plan of each unit was a mirror image of the other. The first floor had a living room, dining room and kitchen and a deck on Side C. The units shared a common entry on Side A. The second floors had two bedrooms and a bathroom.

Note: This floor plan is based on data provided in NIOSH Report F2008-06 and is not drawn to scale. Windows shown as open are based on the narrative or photographic evidence. Door position is shown

based on information provided by NIOSH Investigator Steve Berardinelli (this differs from the NIOSH report which includes a hand drawn fire investigators sketch showing all doors open). Windows shown as intact are not visible in the available photographs, but may be open due to fire effects or firefighting operations (particularly those in the fire unit).

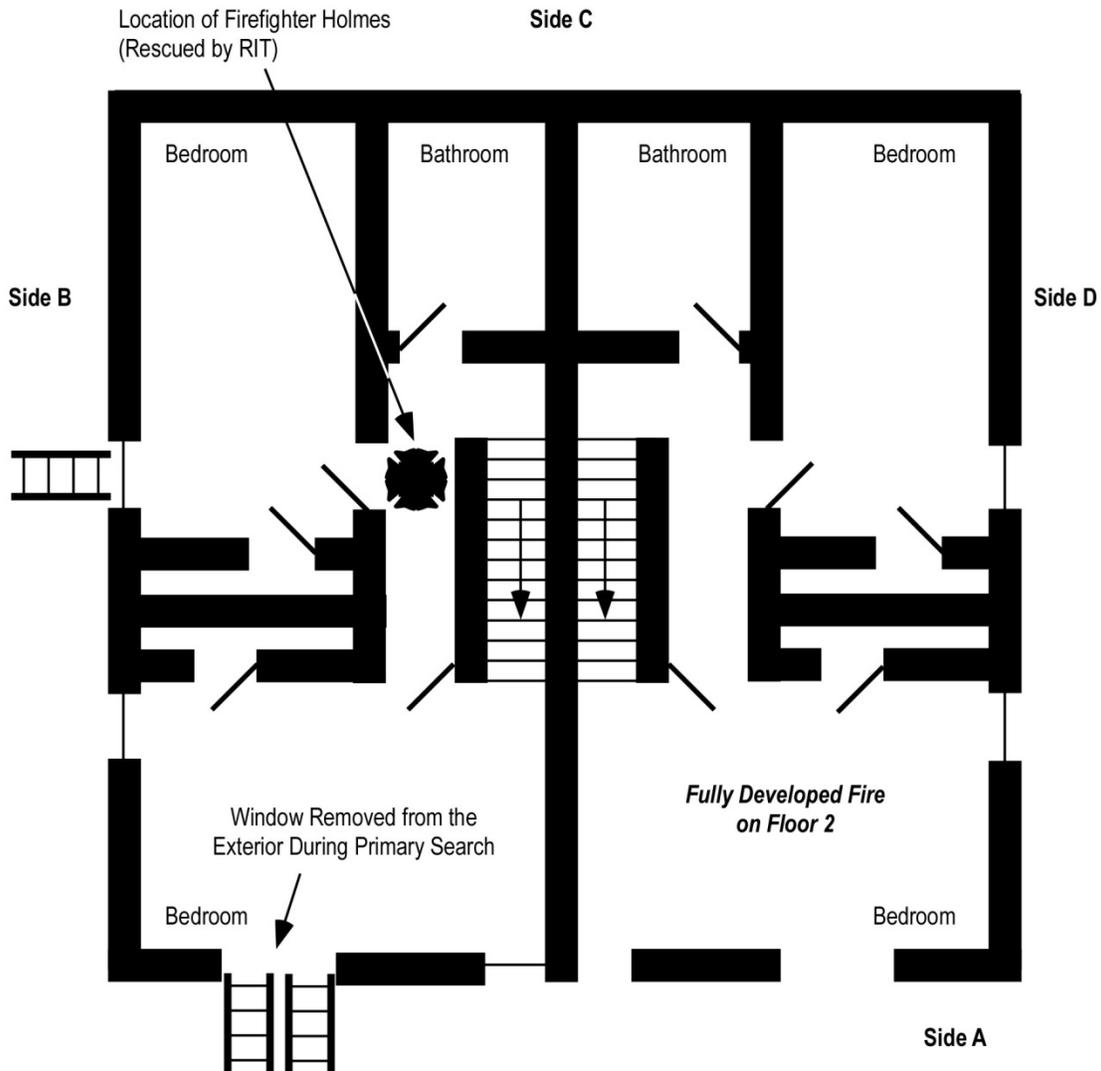
Figure 3. Fire Unit and Exposure Bravo Floor 2

Note: See the prior comments regarding windows and door position.

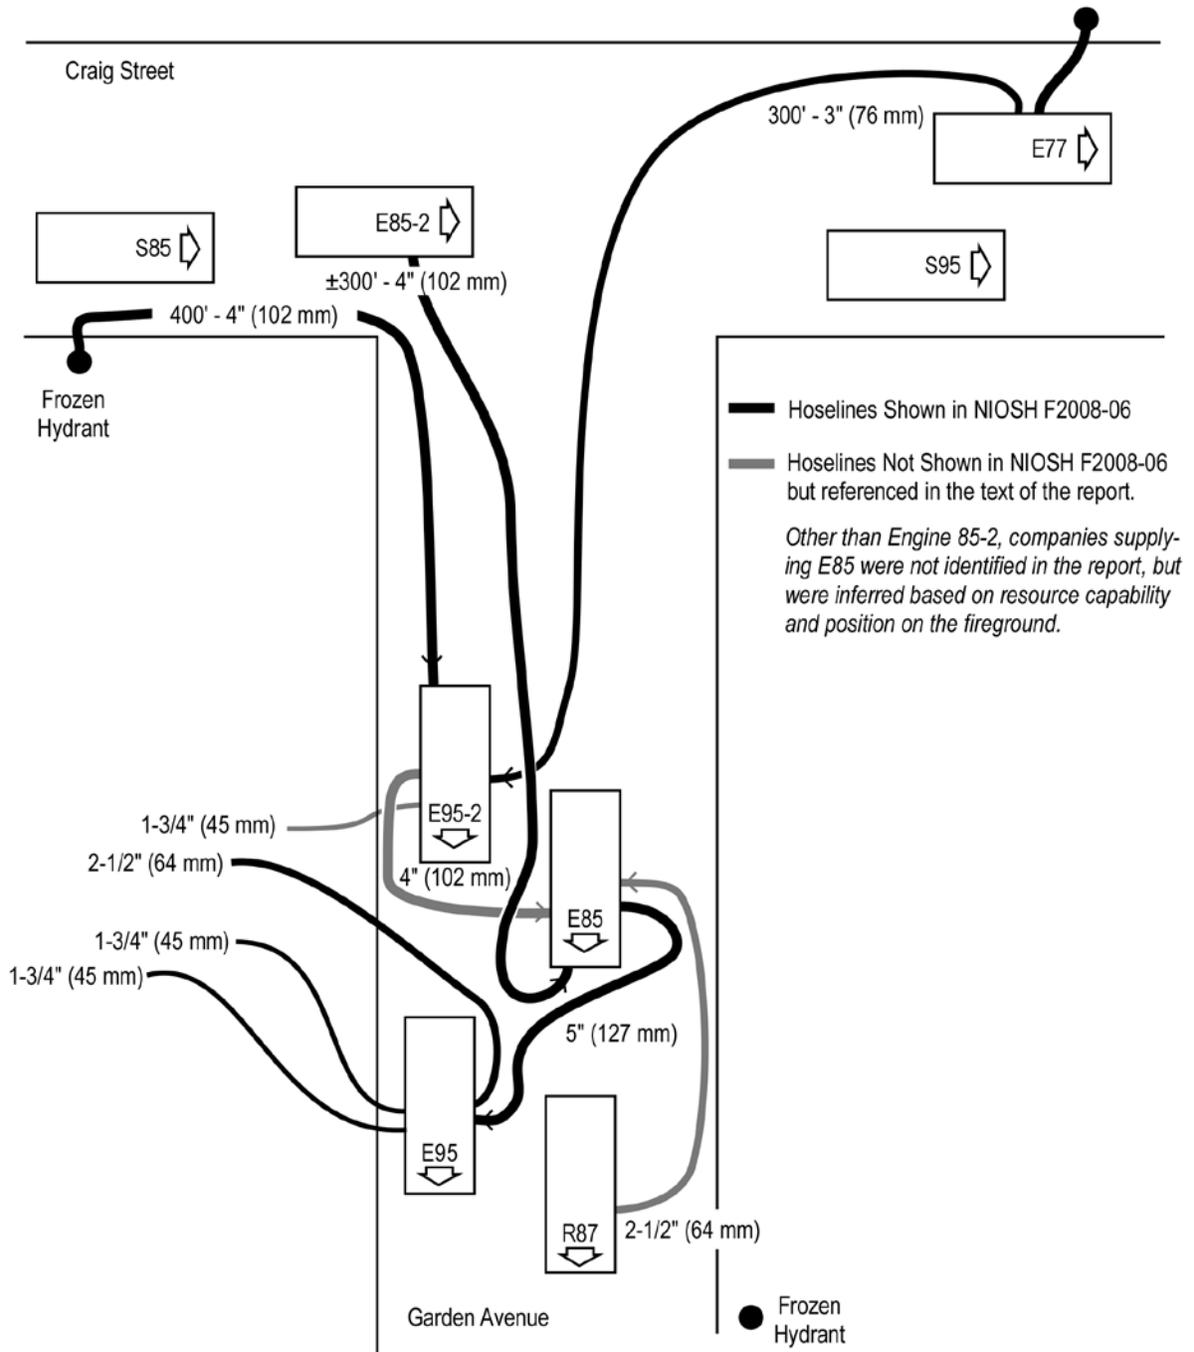
Figure 4. Apparatus Position and Water Supply Operations Prior to 0643 Hours

The hydrant that Engine 95-2 laid in from was frozen as was the closest hydrant on Garden Avenue (several houses beyond the fire building). First alarm companies used tank water to support initial firefighting operations. The crew from Engine 95-2 began to hand stretch a 3" line to a hydrant on Craig Street, east of Garden Avenue. *Due to the complexity of water supply operations, additional detail is provided in a subsequent section of this case.*

As the two closest hydrants to the fire were frozen, water supply was a critical factor in this incident. In an effort to sustain firefighting operations while trying to establish a continuous water supply, tank water from multiple apparatus was transferred to the engines supplying handlines. Figure 5 illustrates the hose layout and water supply operations at the incident prior to the Incident Commander's shift to a strictly defensive strategy. Table 1 illustrates the pump, tank, and supply hose capacities of the apparatus used at this incident.
