# Insulation Fire in Brussels

Lessons learned from incident in uniquely constructed high rise

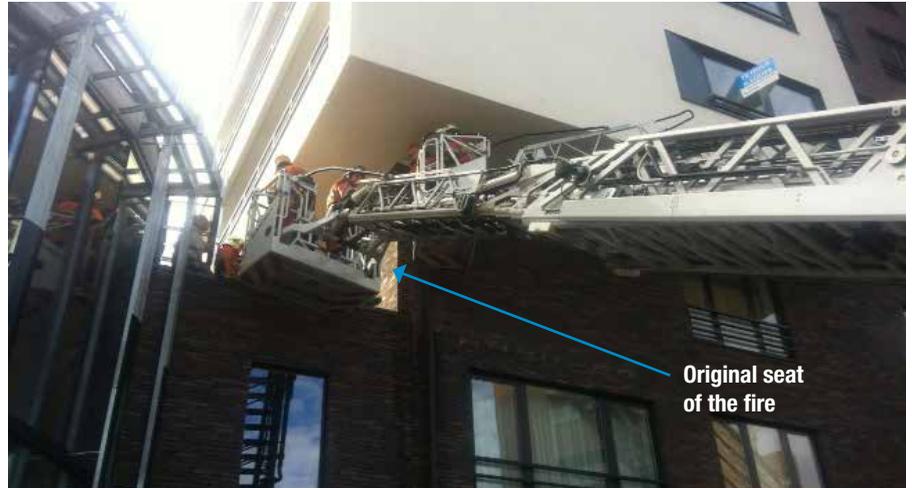
The ladder crew working where the fire started. The section of wall indicated with the bottom blue arrow is about 2 meters wide. The fire could pass the corner and create fire extension across the entire brick wall. Photo by Pieter Maes
