Construction fires: insulation fire in Evere

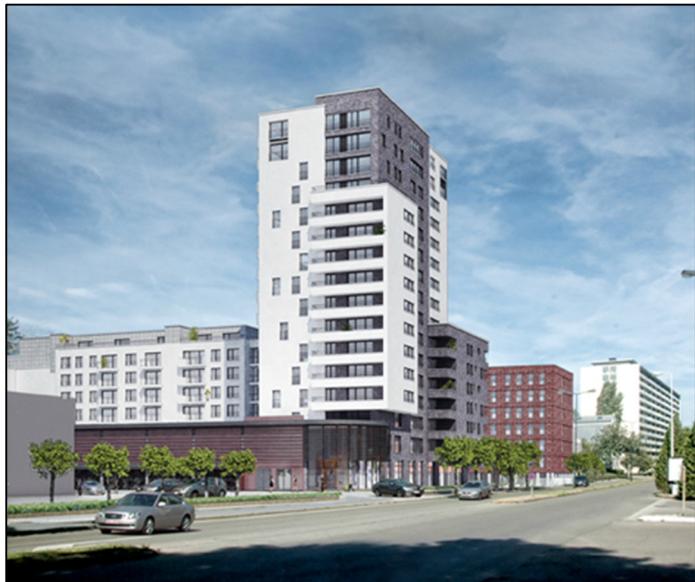
Upon arrival, the fire crews notice that the walls are partially covered with bricks and partially plastered (see Figure 1). The composition of the wall is not really clear at the start.

Figure 1 Illustration of the building. The white panes are exterior plaster while the darker parts of the wall are bricks. At the front left, the side building can be seen. (© Drawing: A2RC)

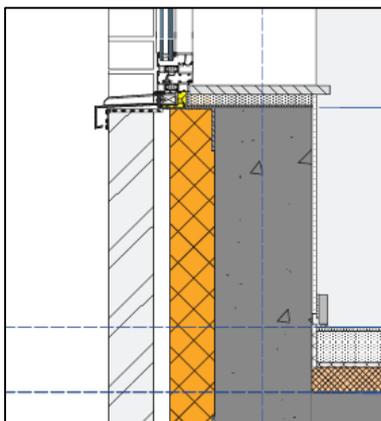
It is assumed that the brick wall is traditional masonry. This means that the interior wall is brick or concrete. Next, going from the inside out, there's a layer of insulation. In this case polyurethane (PUR). The outside wall layer are the bricks visible from the street (see Figure 2).

Figure 2 Construction details of the masonry wall. From left to right: brick, cavity, insulation, concrete wall. (Drawing: A2RC)

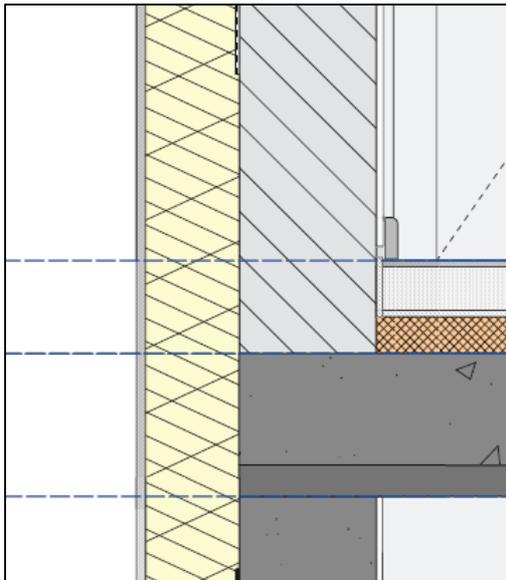
Figure 6 Buildup of the plaster sections. From left to right: exterior plaster, EPS insulation, concrete. (Drawing: A2RC)
