# Ukkel

## 1 Introduction

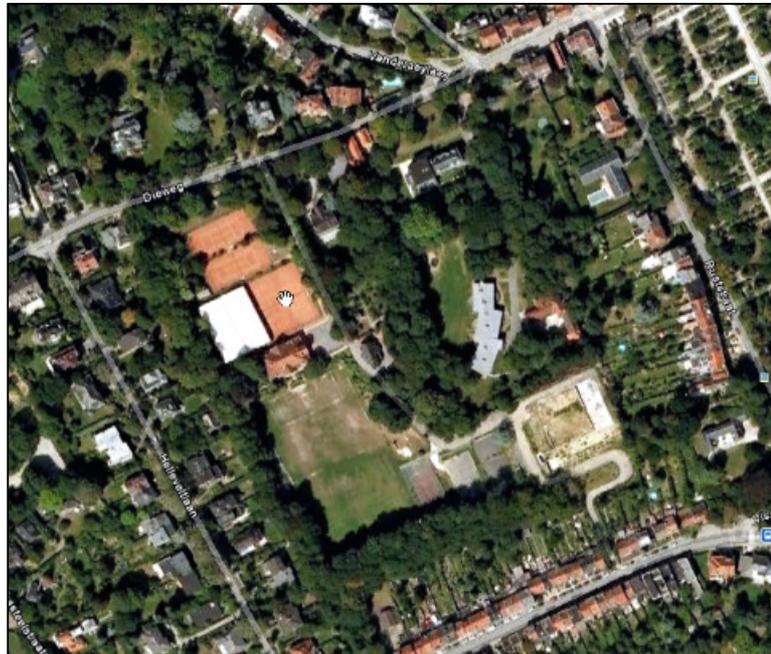
The area between the Dieweg road and the St-Job's road had several buildings on it located in groups. It was a relatively large terrain with a strong slope because the Dieweg road is situated a lot higher than the St-Job's road. The slope is so steep that a hairpin bend has been built in front of the buildings. The slope will turn out to be crucial in this incident. It hinders assessment and size up of the incident.

The size of the terrain causes the distance between the two roads and the place where the vehicles set up, to be very large as well. The vehicles that arrived from the Dieweg road had to drive for about 250 m from the road up to the burning building. Coming from the St-Job's road, it was only 150 m, but that wasn't clear from the start.

**Figure 2** Aerial picture taken after the fire. The upper street is the Dieweg road. The bottom is the St-Job's road. The empty site with the hairpin bend below it, can be clearly seen at the bottom right of the picture. (Photo: Google maps)
