Difficult fire in a museum

January 18th, 2021, the Brussels fire department was confronted with a very complex fire in the Palace for Fine Arts, popularly known as “Bozar”, located at Ravensteinstraat 33 in Brussels. What started as a roof fire eventually turned into a long battle against the fire both from the top of the roof as from under the roof. The cold weather does not make the job any easier. Below you will find the story of this fire.

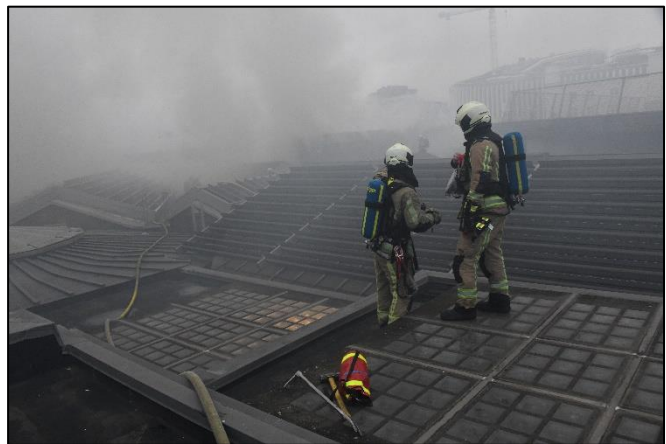
Image 5 Two company officers liaise on the roof. The picture allows to estimate the long distances that have to be travelled on the roof. (Foto: Robert Decock)

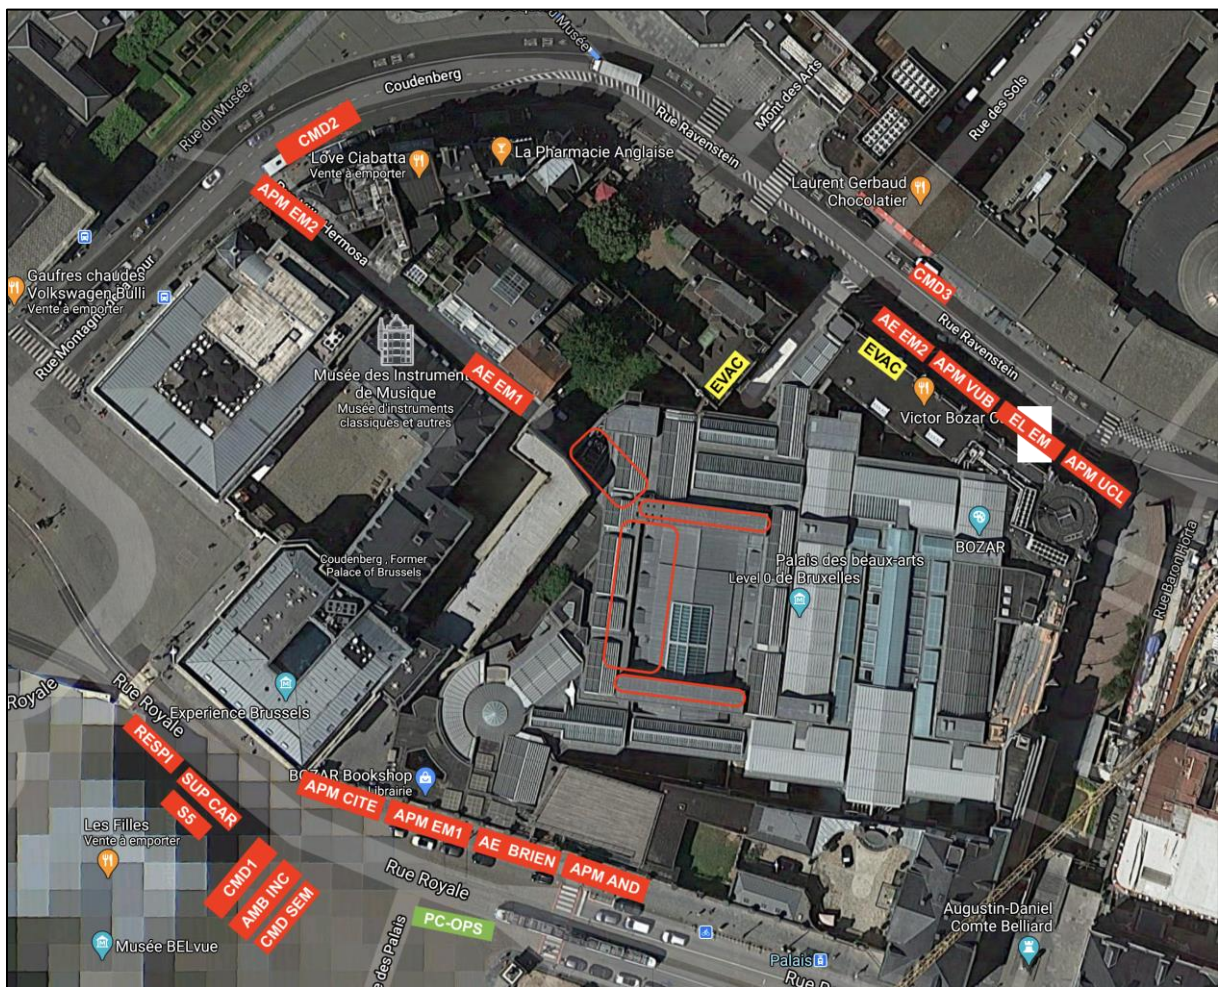
Image 9 Overview of the site with the dedicated vehicles. (Figure: Laurent Ledeghen)
