# Lightweight construction

## 1 Introduction

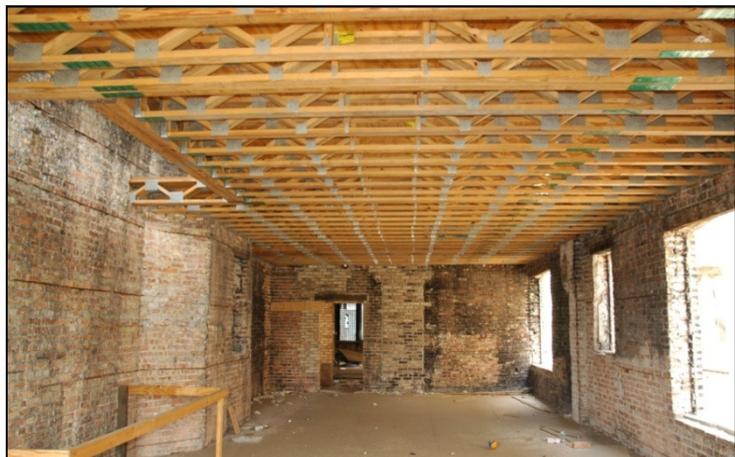
**Figure 1** Wooden trusses (Photo: NIST)

In the past, large dimensional lumber was primarily used for residential construction. Building materials are expensive however. A large solid wooden beam costs more than a wooden rafter. In the US, building methods shifted from using wooden beams to using rafters, I-joists and even small trusses. This particular way of building is called lightweight construction.

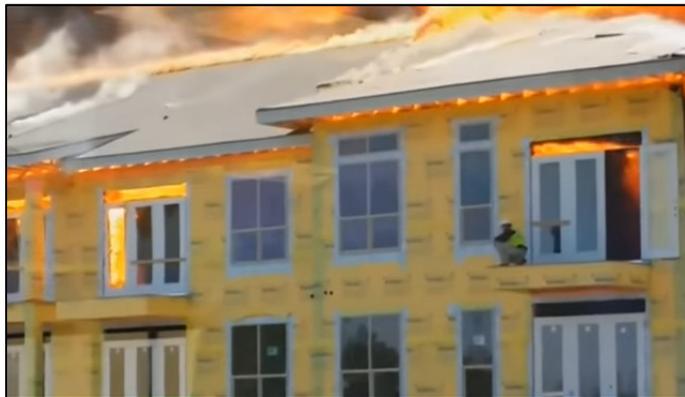
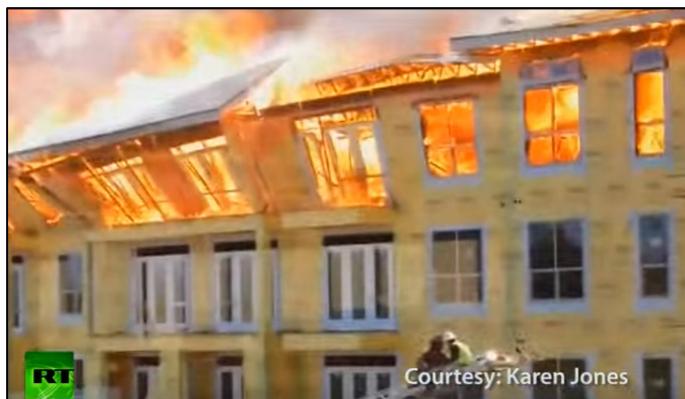
At the start of the clip, we can see that the man has fled onto the balcony. Apparently, there was no time to escape down the stairs. The film clearly shows how fast the fire is spreading. In no time at all, the fire has engulfed the entire top floor.

The man is eventually saved by the fire service using a ladder truck. During this rescue effort, the wall of the top floor collapses. Both screenshots were taken with only a minute and half in between.

**Figure 4 and Figure 5** Two photos show the progress of a fire in a wooden apartment building. (© Footage: Karen Jones)

On YouTube, there is a dramatic video of a fire in Houston, Texas. The clip shows a construction worker that is trapped on a balcony of a wooden apartment building under construction (use search terms "man on balcony in burning building").

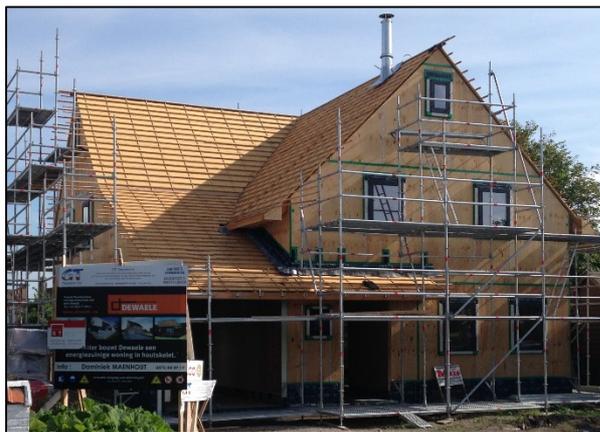
**Figure 6** Construction of a wooden house.  
(Photo: Nathalie Van Moorter)

In Belgium, we have a tradition of building brick houses. There is a Belgian proverb which loosely translates into: “A Belgian is born with a brick in his stomach”. Brick houses are very standard to us. Next to that, status matters a lot too. People want to build a house cheap, but don’t want everyone to see it. So even as the number of wooden houses is increasing, it is not visible in the average Belgian streets. The majority of wooden houses have a brick wall as outer finishing. The wooden construction is therefore very difficult to distinguish from a classic brick building.

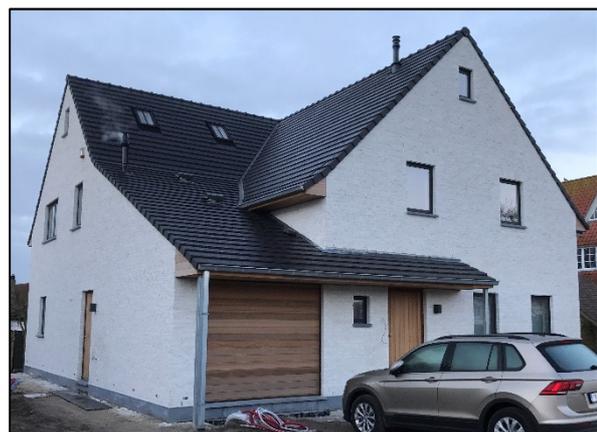
**Figure 7** The same house once finished. Brick was chosen as the finishing outer layer. The house looks the same as a traditional building.  
(Photo: Nathalie Van Moorter)

If a fire were to start in such a house, there is the risk that firefighters will be caught off guard. Upon arrival, nothing would immediately indicate that there is a wooden house involved. At a ventilated fire, fire crews would likely face a fire exiting from windows and doors. Such a fire signifies a massive thermal attack onto the walls and ceiling. Experience tells fire crews that this is not a problem for a brick and concrete building. This is not the same however for wooden houses. When the fire service is faced with a fire on the ground floor during nighttime, performing search & rescue on the upper floor is not without risks. Possibly the fire has weakened the construction to a degree that the search crew could fall through the floor. In that case, they could fall directly into the fire room.
