Building A Better Fire Department

Case Studies in Extreme Fire Behavior

12-Minutes On the Fireground

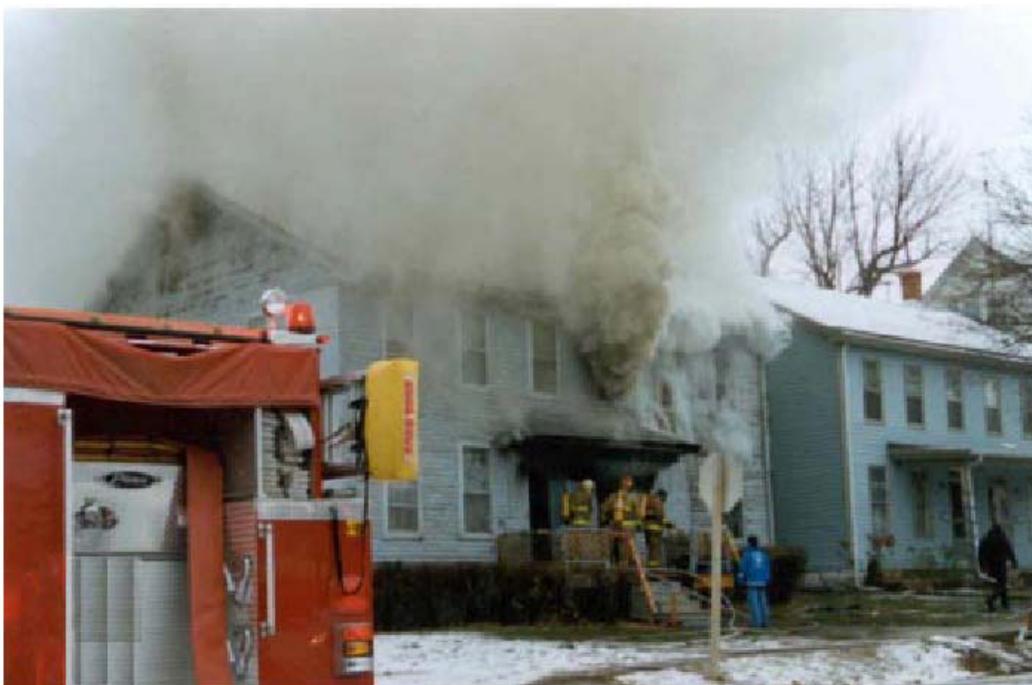
Figure 2. The fire building viewed from the Alpha/Bravo Corner.

● Photo by Cindy Iutzi (from NIOSH Report F2000-04)

This incident involved an early morning fire in a two-story, wood frame duplex that resulted in the deaths of three children and three firefighters. The fire occurred in the unit on Side Bravo of the structure (See Figure 2). This building was originally constructed in the 1870s as a single family dwelling and divided into two dwelling units in the 1970s. This case study will focus on fire behavior related aspects of this incident. However, this case provides an opportunity to learn a number of other important lessons (see the NIOSH and NIST reports for additional information on the incident).

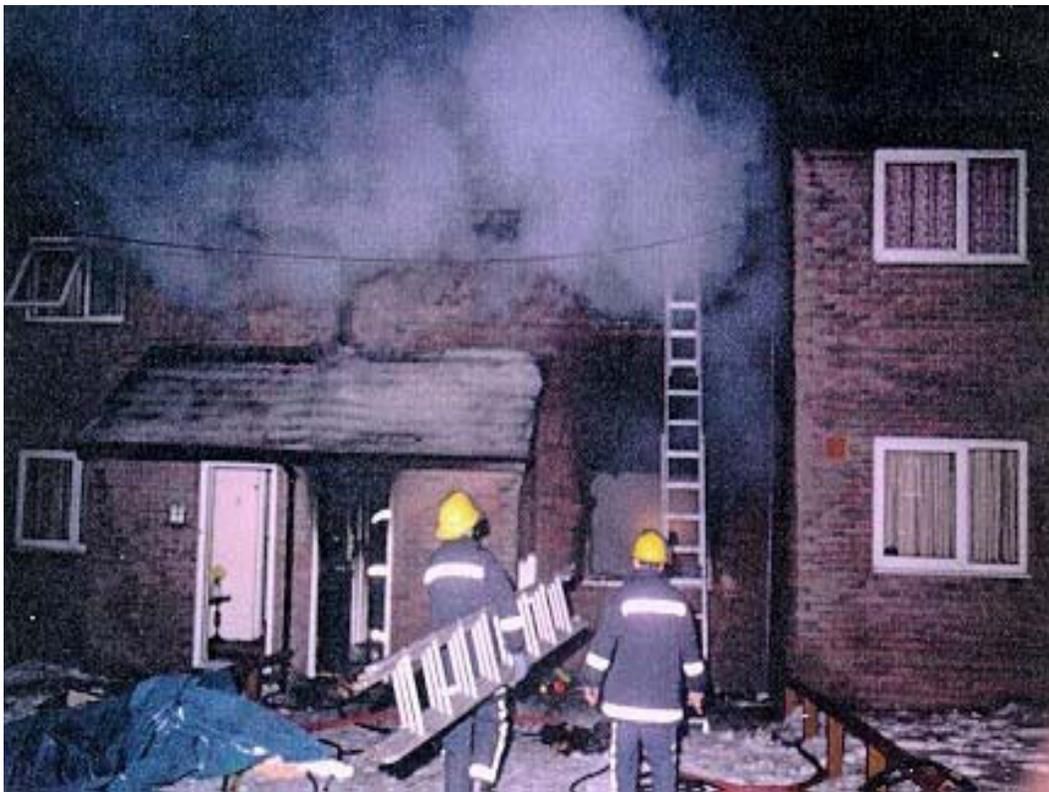
Figure 8. The Fire Building from Side Alpha

Photo from FBU Report

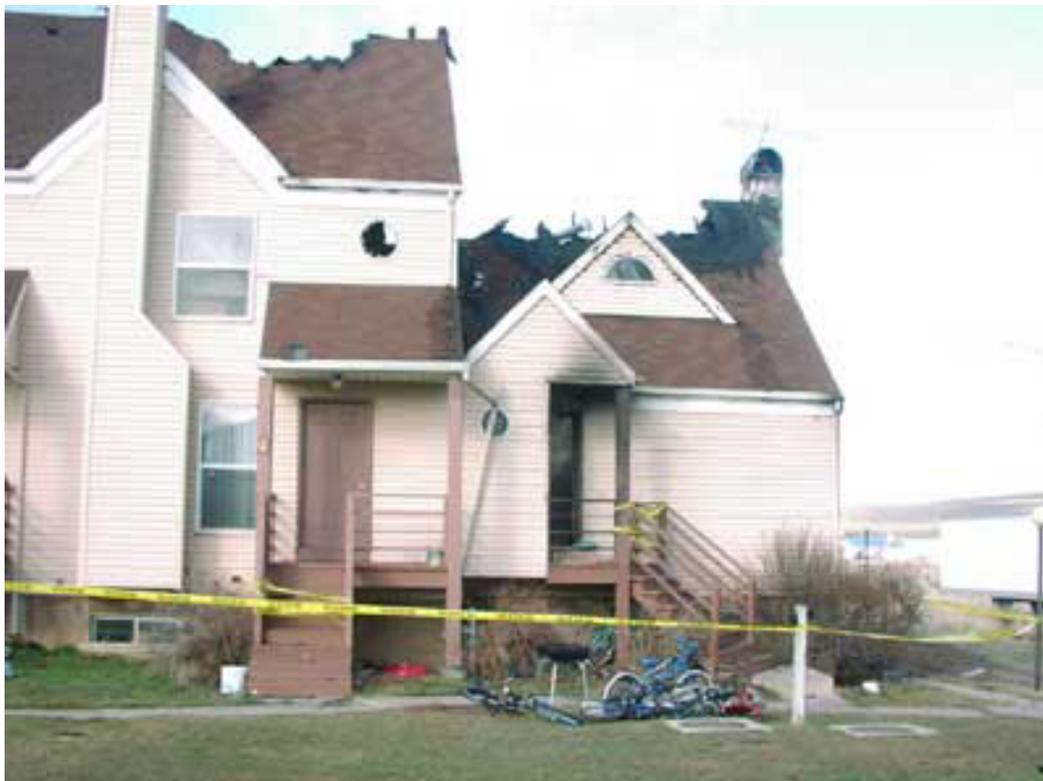
Figure 11. View of the Involved Unit from Side Alpha

Photo from NIOSH Report F2005-13

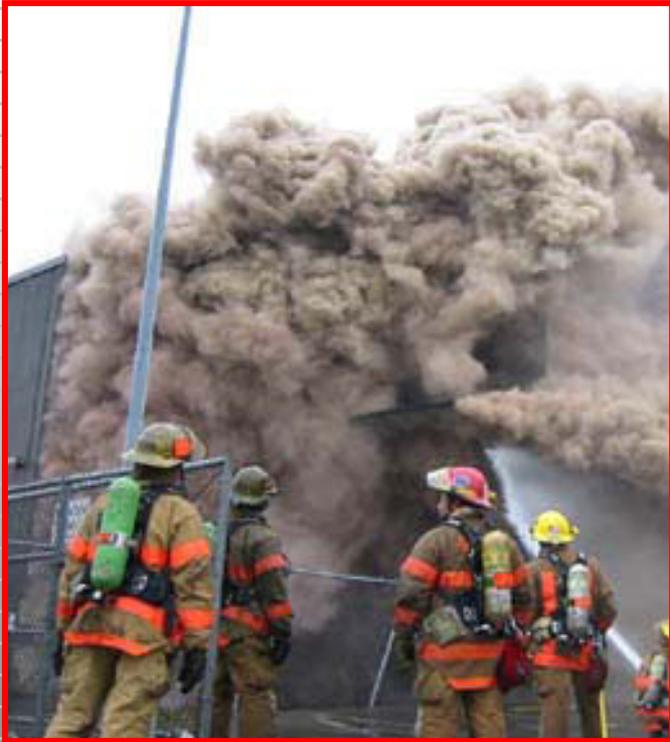
Burning Regime

- ▶ Fuel-Controlled
Fire growth is predominantly limited by the fuel availability and characteristics
- ▶ Ventilation-Controlled
Fire growth is predominantly limited by the available oxygen supply

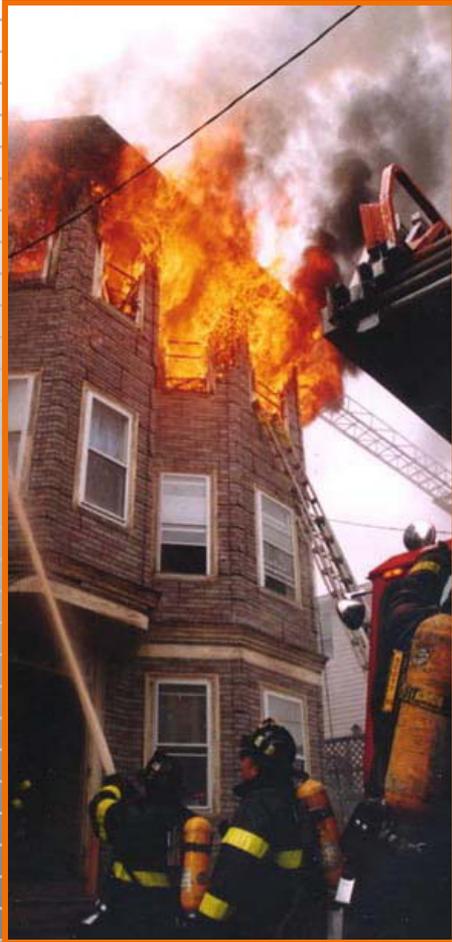
Sequential Effects

- ▶ A fire in a compartment may or may not reach flashover...
- ▶ Transient fire behavior in and of itself does not generally result in a sustained increase in fire intensity. However...

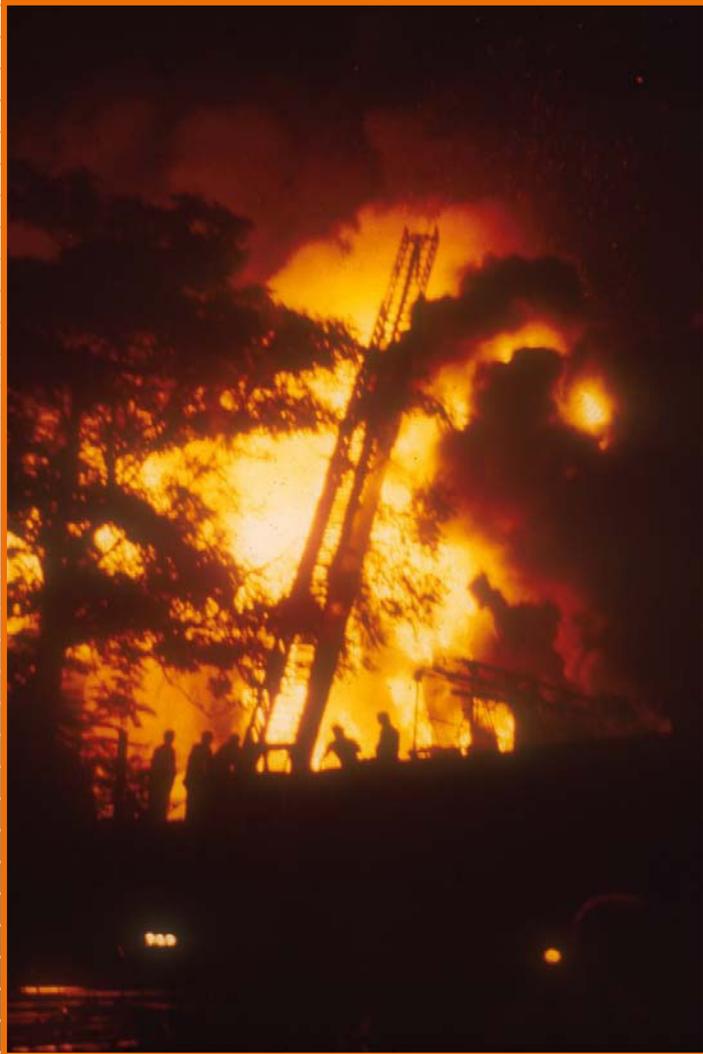
Sequential Effects

- ▶ Fire in the basement of a five-story, heavy timber meat packing plant
- ▶ Yellowish brown smoke pushing with high velocity from floor four
- ▶ A backdraft followed horizontal ventilation of floor four
- ▶ Flashover of all floors lead to full involvement with extension to other buildings
